EcoPark Operation

Annual EM&A Compliance Report

January to December 2011

Project/Deliverable Number:	J494A D02/02
Project Name:	EcoPark Operation EM&A
Report Name:	Annual EM&A Compliance Report – January to December 2011
Report Date:	February 2012
Report for:	Serco Guardian JV

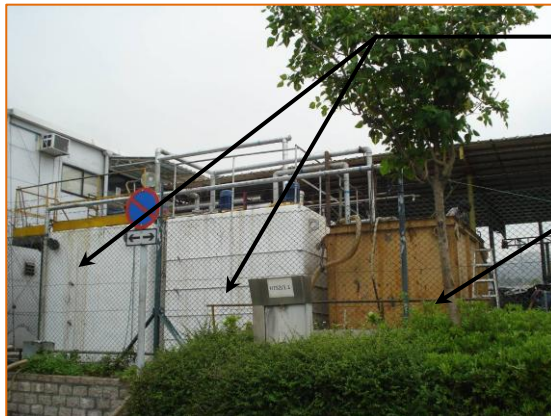
Photo 1 The Recently Installed Storage Tanks

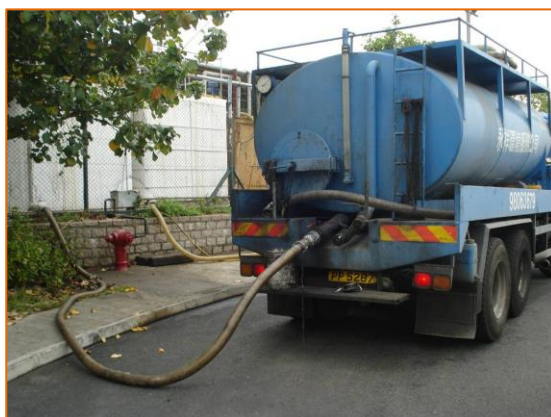
Photo 2 Transference of Oil/Water Mixture from Tanker to Oil/Water Mixture Storage Tanks

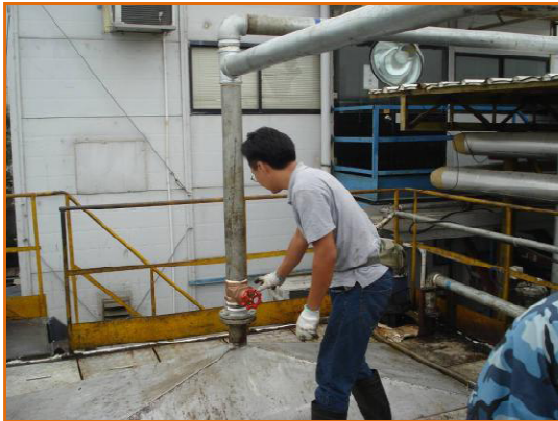
Photo 3 Control Valves of the Air Extraction System Installed at the Oil/Water Storage Tanks

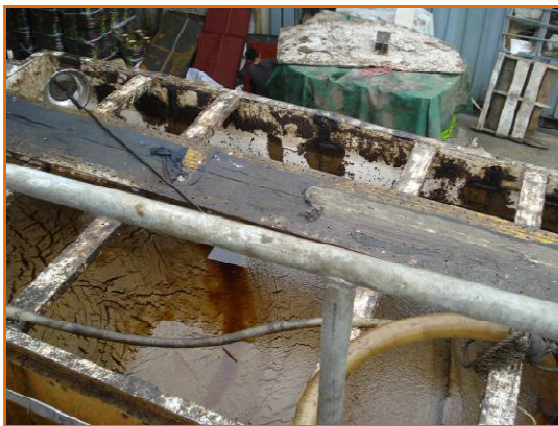
Photo 4 Top View of the Storage Tank for Unwanted Water With Dregs

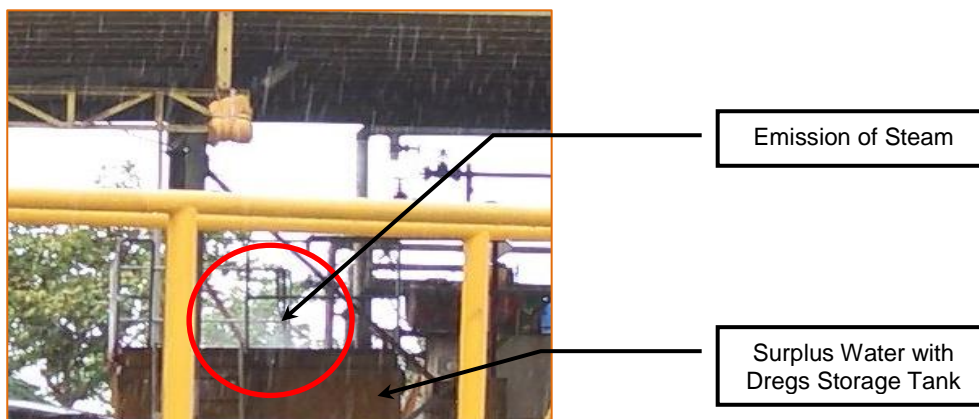
Photo 1 Steam emitted from gaps of the cover of the Surplus Water with Dregs Storage Tank

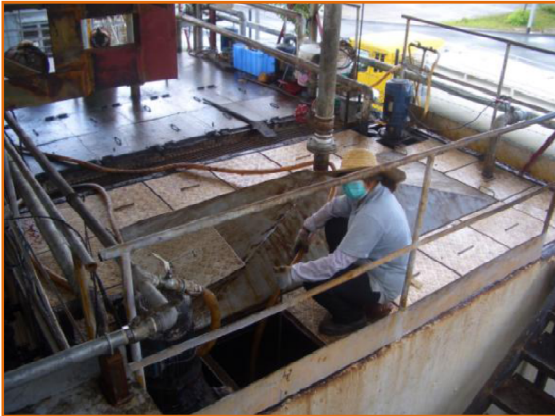
Photo 2 Cleaning or Transference of oil at the Oil/Water Mixture Storage Tanks

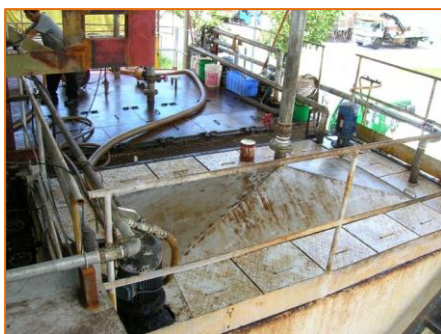
Photo 1 Covers of the Oil/Water Mixture Storage Tanks and Surplus Water with Dregs Storage Tank Remained Closed

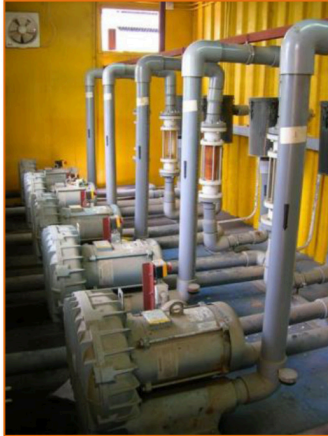
Photo 2 Air Extraction System inside the Activated Carbon Storage Container

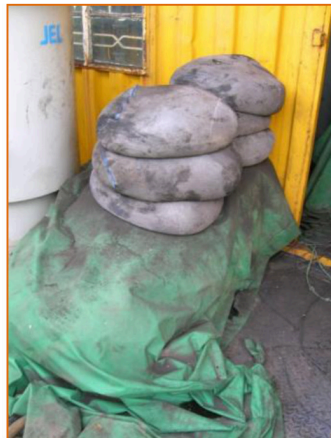
Photo 3 The Storage of Activated Carbon in the Open Environment
