Contract No. : EP/SP/52/06
Development of EcoPark in Tuen Mun Area 38

ENVIRONMENTAL MONITORING AND AUDIT

MONTHLY EM&A REPORT for

December 2009

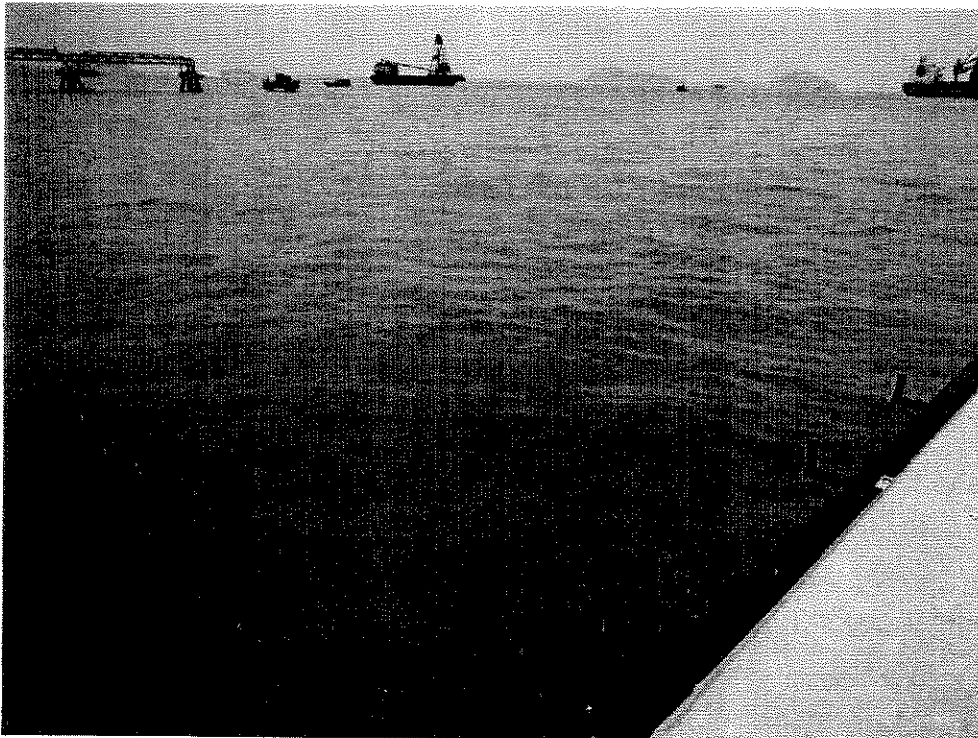
Fig. 1 No muddy water discharge was observed by waterfront.

Since there was no water discharge at manhole, the Contractor removed the silt curtain installed at discharge point on 4 April 2007, as agreed by the Engineer's Representative. Muddy water was observed at discharge point for Phase I construction site on 14 August 2009. The contractor was reminded to consider using a slit curtain if the discharge continues. As informed by Engineer's Representative, there was no direct water discharge at manhole in Phase II construction site. No muddy water discharge is expected.
