Contract No. : EP/SP/52/06
Development of EcoPark in Tuen Mun Area 38

ENVIRONMENTAL MONITORING AND AUDIT

MONTHLY EM&A REPORT for

May 2009

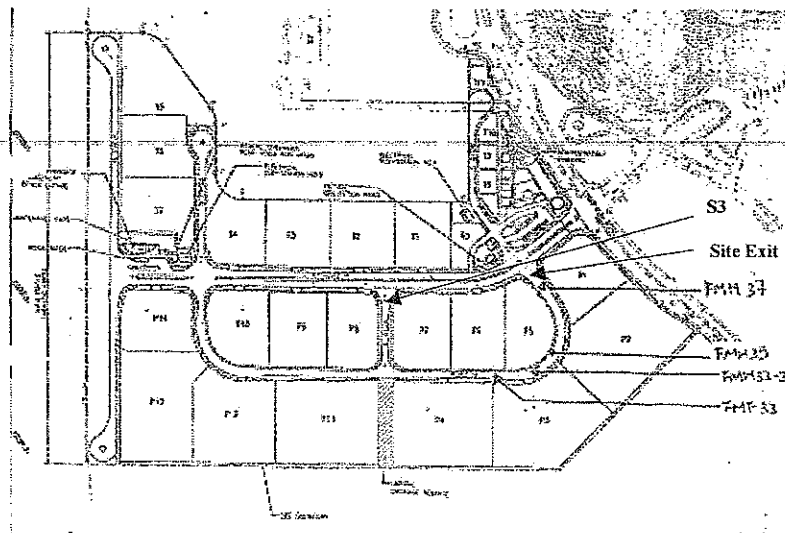
Date of Monitoring: 21 May 2009

21 May 09	LFG monitoring equipment was sent for battery replacement and unavailable on site. LFG monitoring was suspended for one week.	Proper equipment for LFG monitoring should always be available. Spare monitoring equipment should be provided to minimize influence due to breakdown / other reasons.	LFG monitoring equipment was sent back for monitoring.	29 May 2009

* LFEI monitoring equipment was unavailable on site
