Contract No. : EP/SP/52/06
Development of EcoPark in Tuen Mun Area 38

ENVIRONMENTAL MONITORING AND AUDIT

MONTHLY EM&A REPORT for

November 2009

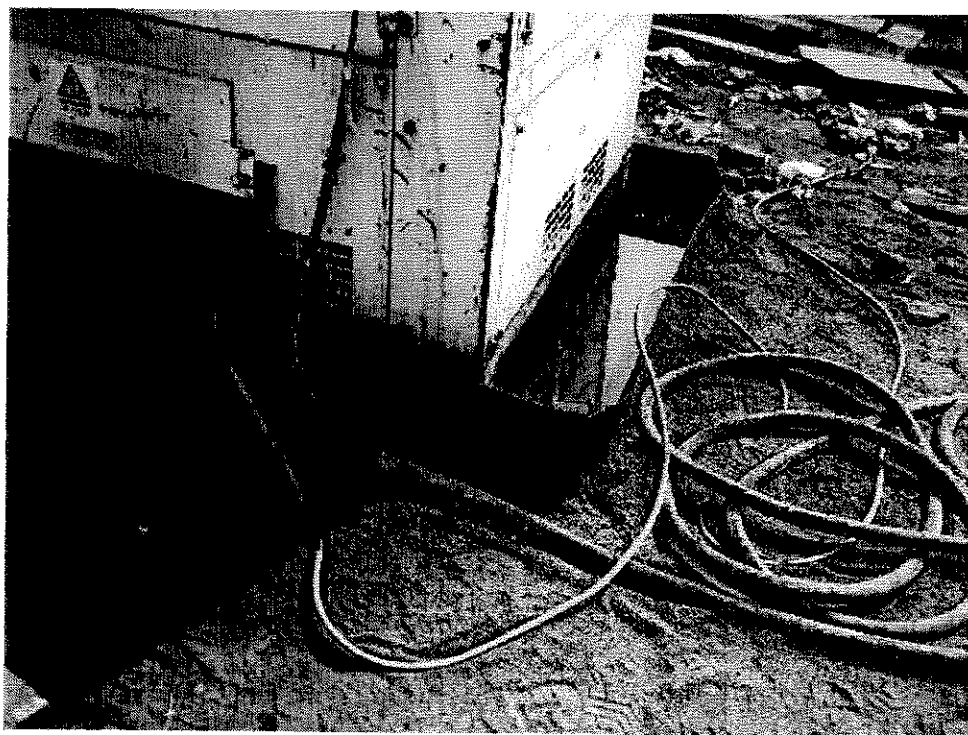
18 September 09	Diesel overflowed into the drip tray for the power generator and surrounding areas.	Contractor was advised to monitor the diesel filling process and ensure the valves on the drip trays shuts completely.	Contractor reminded the workers to be careful on the filling process and overflowing did not occur again.	02 October 09 (Ref. Fig. 1)
October 09	Drip pan has not yet been provided for the three plastic chemical drums adjacent to the cooling tower in the administration building.	ET was informed that a proper drip pan has been designed and will be constructed in October. Contractor was reminded to install the drip pans as soon as possible.	Contractor installed drip pans for the plastic chemical drums.	13 November 09 (Ref. Fig. 2)
23 October 09 to 13 November 09	Hoardings beside Road A have been removed temporarily due to construction program.	Contractor was reminded to re-install hoardings to prevent dirt and dust being brought outside of construction site by wind.	Contractor installed plastics wraps to prevent dirt and dust being brought outside of construction site by wind.	20 November 09 (Ref. Fig. 3)

Fig. 1 Drip tray leakage was repaired.

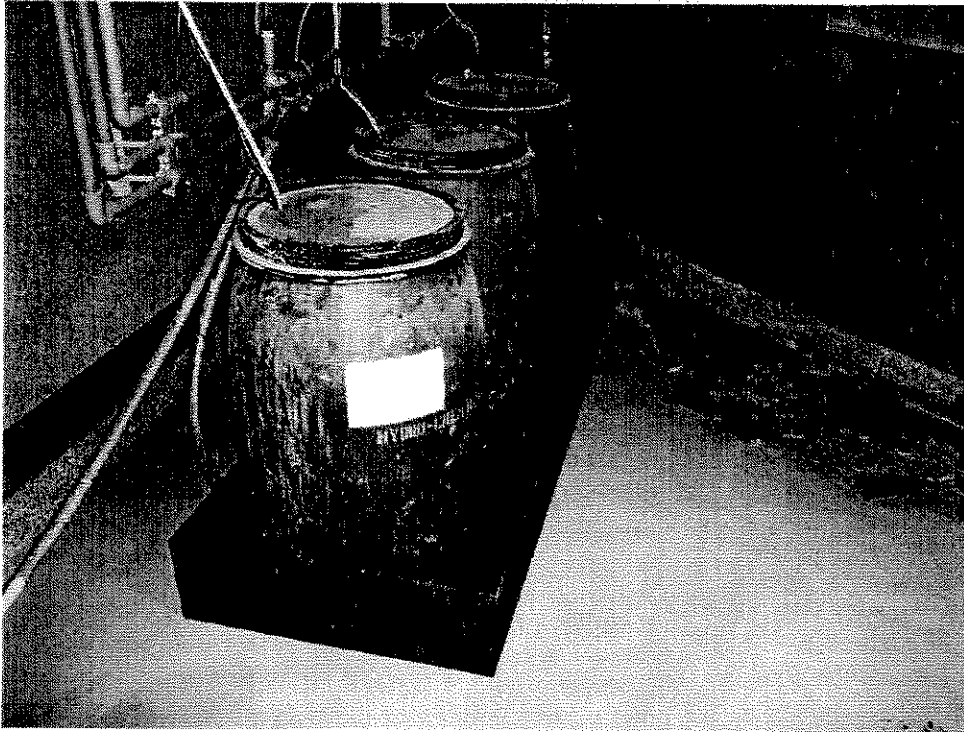
- 3) Drip pan has not yet been provided for the three plastic chemical drums adjacent to the cooling tower in the administration building. ET was informed that a proper drip pan has been designed and will be constructed in October. Drip pans were provided on 13 November 2009.

Fig. 2 Drip pan is provided for the three plastic chemical drums adjacent to the cooling tower in the administration building.

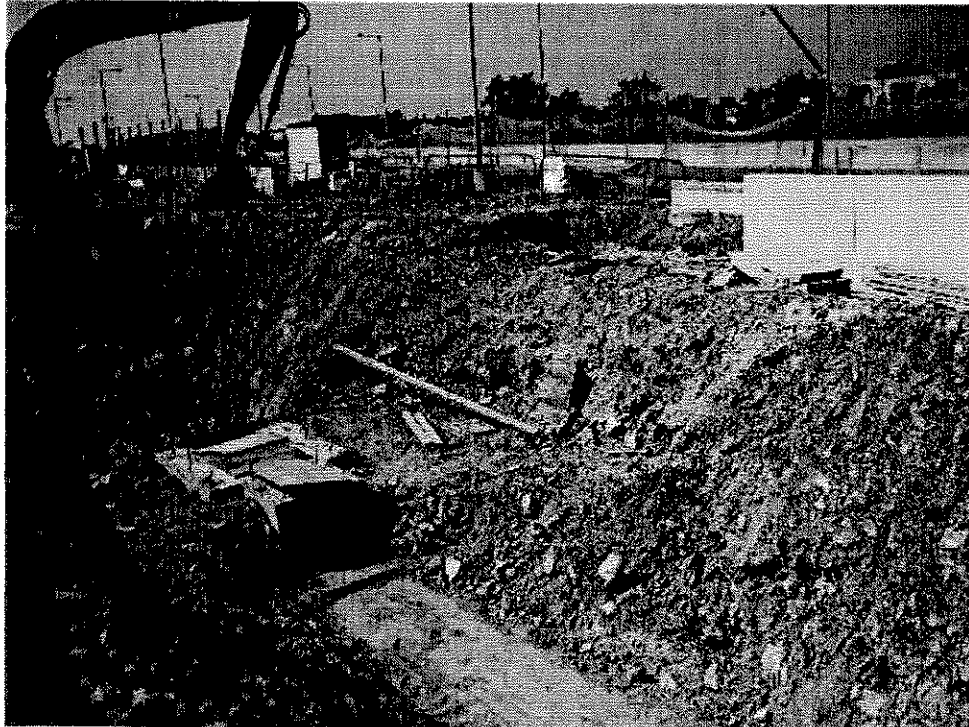
02 October 09 to 27 November 09	Sections of hoardings on Road A are loosened.	Contractor was reminded to repair and mount the loosened sections properly to prevent dirt and dust being brought outside of the construction site by wind.	Contractor took action to re-mount the hoardings properly.	To be followed in the next reporting month. (Tentative closing date: 31 December 2009)
09 October 09 to 27 November 09	Road A near construction site exit is covered with dirt and dust.	Contractor is reminded to manually wash the vehicles leaving the construction site before the automatic wheel washing machine is repaired or replaced.	Contractor reminded instructed drivers and workers to manually wash wheels of vehicles until further notice.	To be followed in the next reporting month. (Tentative closing date: 31 December 2009)

Fig. 3 Contractor installed plastic wraps to prevent dirt and dust being brought outside construction site by wind.

- 4) Sections of hoardings on Road A are loosened. Contractor was reminded to repair and mount the loosened sections properly to prevent dirt and dust being brought outside of the construction site by wind. Tentative closing date is 31 December 2009.
