Contract No. : EP/SP/52/06
Development of EcoPark in Tuen Mun Area 38

ENVIRONMENTAL MONITORING AND AUDIT

MONTHLY EM&A REPORT for

October 2009

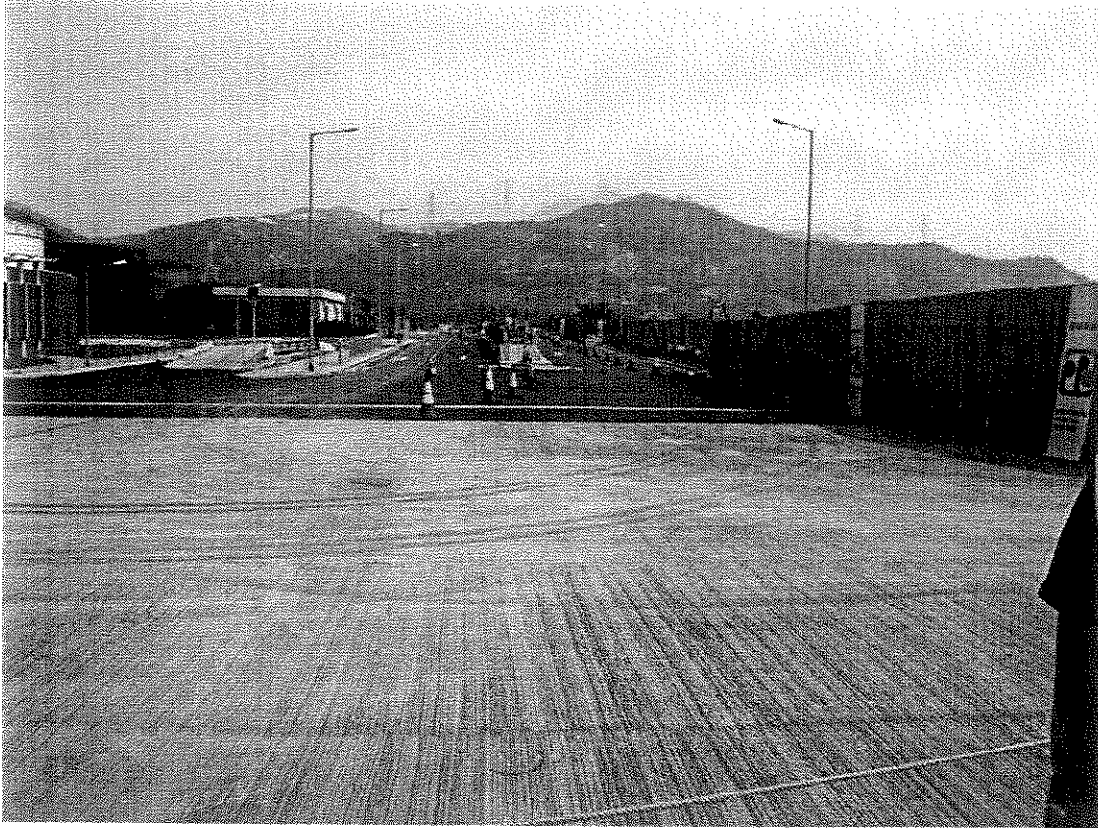
- 5) Sections of hoardings and fabric wraps along Road A were damaged by the typhoon on 18 September 2009. Contractor was reminded to repair the damaged hoardings and replace the fabric wraps to prevent dirt and dust being brought outside the construction site by wind.

Fig 1. Hoardings damaged by typhoon were restored.

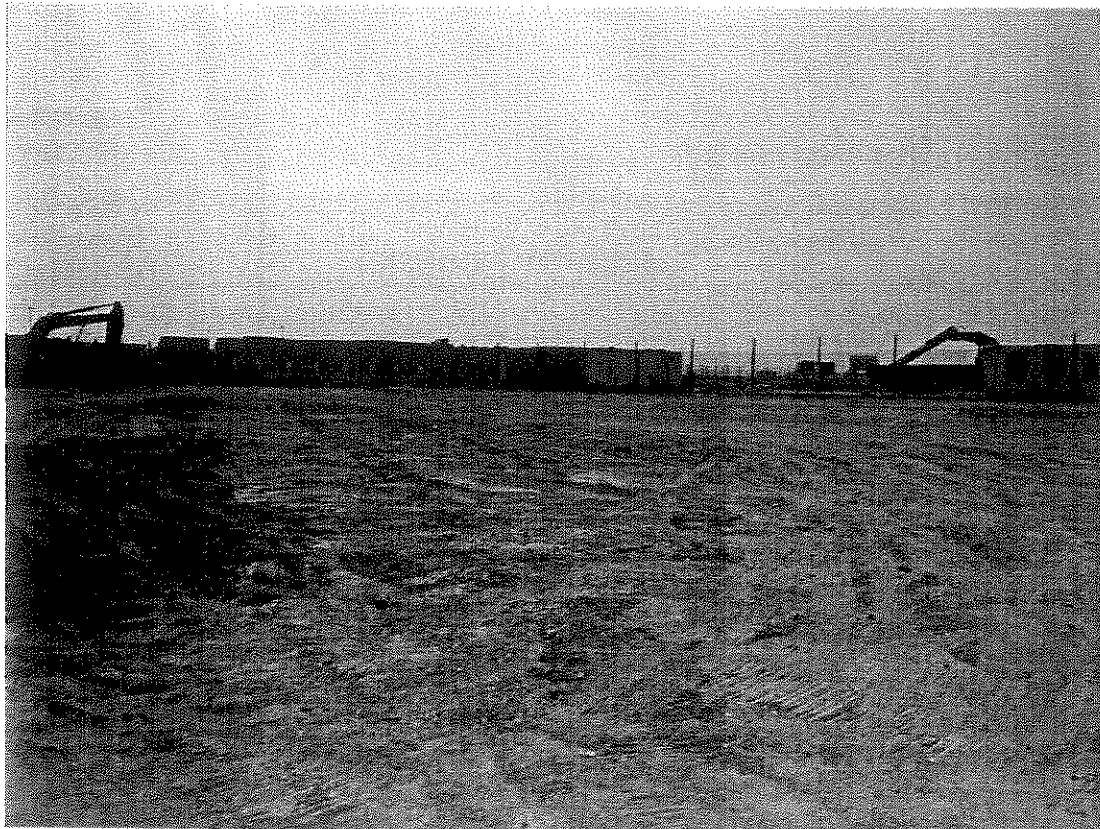
- 6) Pools of stalled water are found near lot P10 on 25 September 2009. Contractor was reminded that accumulated water should be treated properly to meet requirements specified in the issued discharge license, if appropriate.

18 September 09	Diesel overflowed into the drip tray for the power generator and surrounding areas.	Contractor was advised to monitor the diesel filling process and ensure the valves on the drip trays shuts completely.	Contractor reminded the workers to be careful on the filling process and overflowing did not occur again.	02 October 09 (Photographic proof will be available in the next reporting month)
18 September 09	Sections of hoardings and fabric wraps along Road A were damaged by typhoon.	Contractor was reminded to repair the damaged hoardings and replace the fabric wraps to prevent dirt and dust being brought outside of the construction site by wind.	Contractor took action to replace the fabric wraps along the damaged sections.	02 October 09 (See Fig. 1)
25 September 09	Pools of stalled water are found near lot P10.	Contractor was reminded that accumulated water should be treated properly to meet requirements specified in the issued discharge license, if appropriate.	Contractor took action to remove and treated the muddy water near lot P10.	02 October 09 (See Fig. 2)

Fig 2. Lot P10 has been flattened and no stalled water can be found.

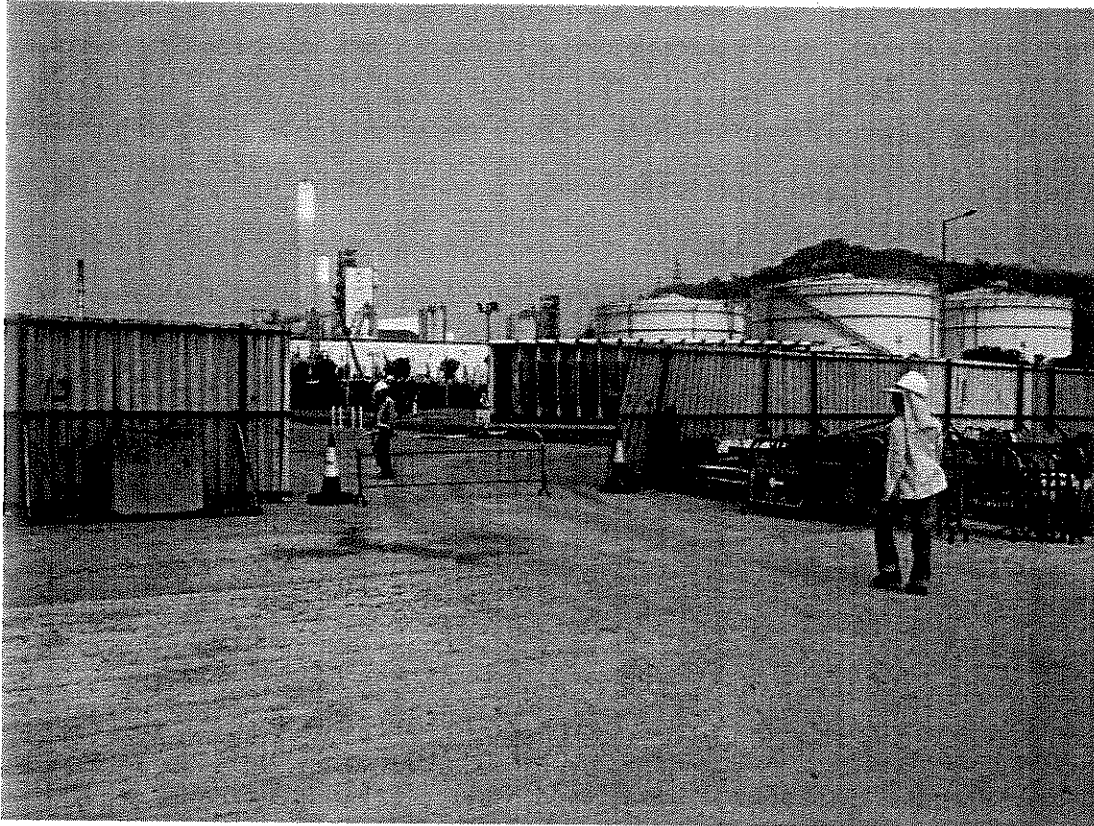
02 October 09 09 October 09 16 October 09	Sections of hoardings on Road A are loosened.	Contractor was reminded to repair and mount the loosened sections properly to prevent dirt and dust being brought outside of the construction site by wind.	Contractor took action to re-mount the hoardings properly.	To be followed in the next reporting month. (Tentative closing date: 30 November 2009)
09 October 09	Road A near waterfront is covered with dirt and dust, due to construction vehicles using the exit without any wheel washing facilities.	Contractor was reminded to properly fence off the site entrances and exits without any wheel washing facilities.	Contractor took action to wash dirt off the road and to block off the site entrance near waterfront to prevent heavy vehicle to pass through.	16 October 09 (See Fig. 3)

Fig 3. Contractor blocked off temporary site entrance near waterfront.
