# **EcoPark Operation EM&A**

Quarterly Report

## November 2009 to January 2010

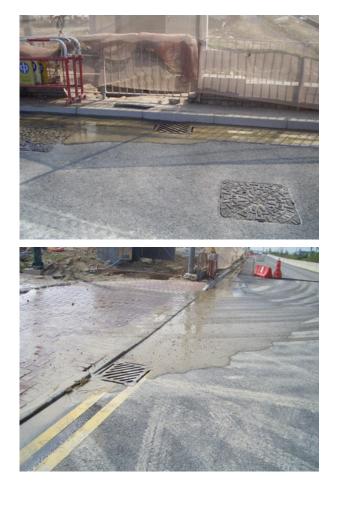
Outside the tenant lot of Yan Oi Tong, muddy runoff from the vehicle washing facility was found to enter the drains directly. SGJV was advised to liaise with the RE regarding the muddy water discharge from Phase 2.

During the site inspection on 25 Jan 2010, no muddy water was found outside the tenant lot of Yan Oi Tong; instead, muddy trial was found near the drains. SGJV was advised to liaise with the RE for clearing the muddy trial. (Outstanding)
