Serco Guardian JV

EcoPark Operation EM&A

Quarterly Report

May to July 2010

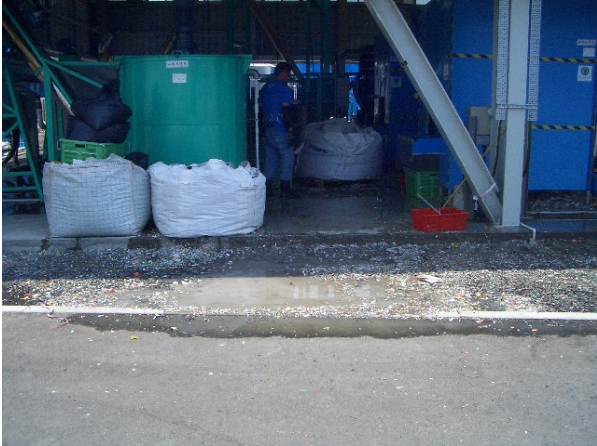
No.	Observation (Please include location and recommended remedial action)	Expected Date for Action Taken
1	<p>Wastewater for washing waste plastics was not diverted to the wastewater treatment facility and stagnant pool of wastewater was found. The tenant was reminded to divert all wastewater to the treatment facility and put appropriate control measures in place.</p>

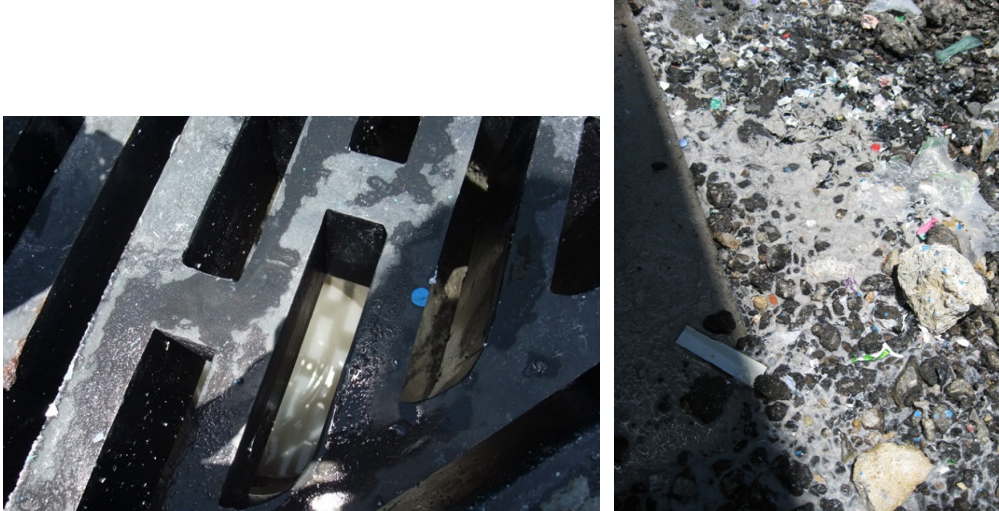
No.	Observation (Please include location and recommended remedial action)	Expected Date for Action Taken
1	<p>Turbid water was found inside the drains behind Area C. The tenant was reminded to divert all wastewater from washing waste plastics to the treatment facility and avoid such situation from happening again.</p>

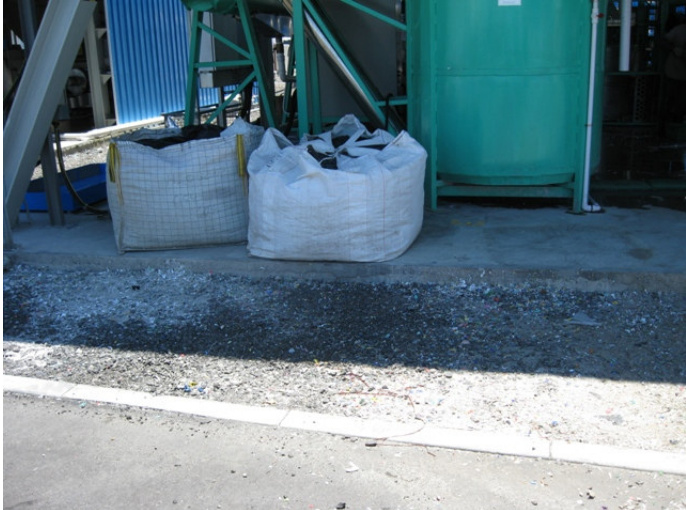
5 July 2010
No.	Follow-up from Previous Audit Dated <u>25 May 2010</u> (Please state date of previous audit)	Completed / Outstanding?
1	<p>Wastewater generated from washing waste plastics could no longer be found in front of Area B.</p>

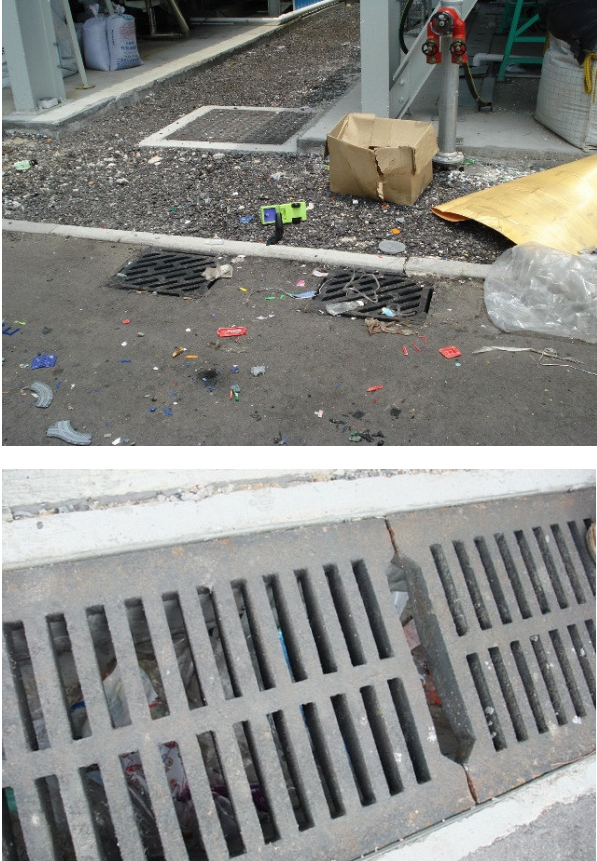
No.	Observation (Please include location and recommended remedial action)	Expected Date for Action Taken
1	<p>Refuse was found around the lot and inside stormwater drains. The tenant was reminded to enhance housekeeping and prevent refuse from entering the drains.</p>

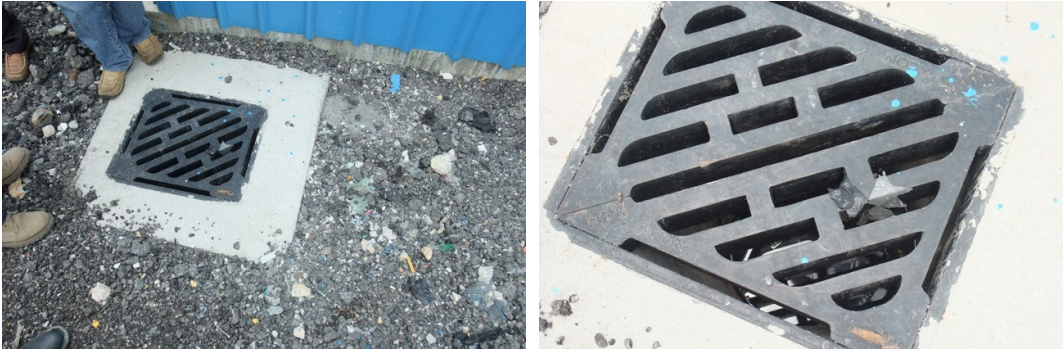
3 August 2010
No.	Follow-up from Previous Audit Dated <u>21 June 2010</u> (Please state date of previous audit)	Completed / Outstanding?
1	<p>Turbid water was no longer found inside the stormwater drains behind Area C.</p>

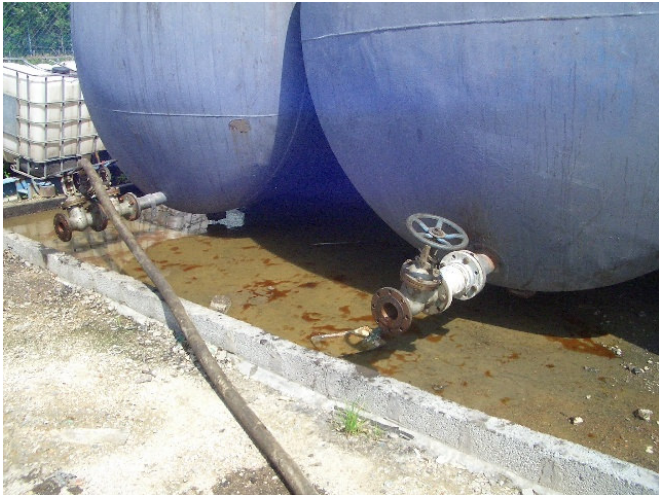
No.	Observation (Please include location and recommended remedial action)	Expected Date for Action Taken
1	<p>At the reserved area for EcoPark's Wastewater Treatment Plant (WWTP), stagnant water with oil floating on top was observed near the storage tanks. The tenant was reminded to remove the stagnant water as soon as possible so as to prevent mosquito breeding.</p>

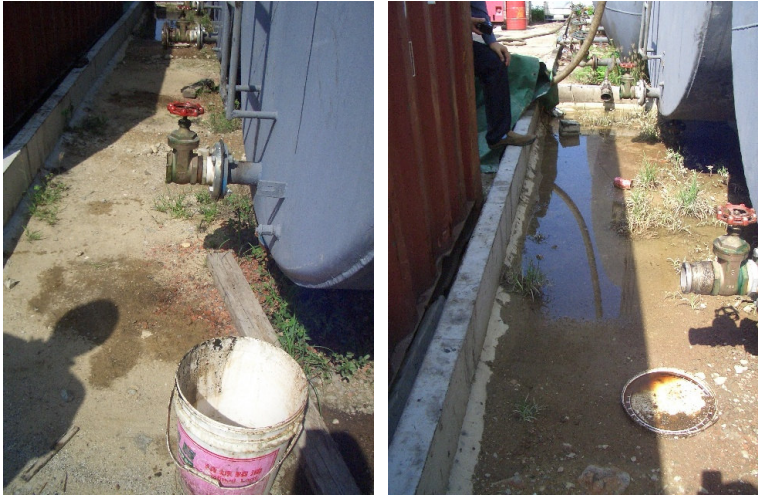
1 June 2010
No.	Follow-up from Previous Audit Dated <u>28 April 2010</u> . (Please state date of previous audit)	Completed / Outstanding?
1	<p>At the reserved area for EcoPark's WWTP, oil stain was observed near the storage tanks. In addition, uncovered waste cooking oil bucket was observed on the bare ground. The tenant was again reminded to remove the oil stain and dispose of the waste properly, and provide cover to the buckets as well as drip tray / canvas underneath the storage tanks.</p>

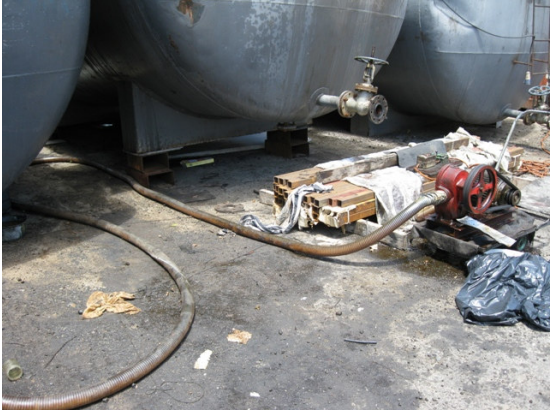
No.	Observation (Please include location and recommended remedial action)	Expected Date for Action Taken
1	<p>Oil stain was found near the storage tanks inside the lot. The tenant was reminded to cover the stain by sand and dispose of the sand properly.</p>

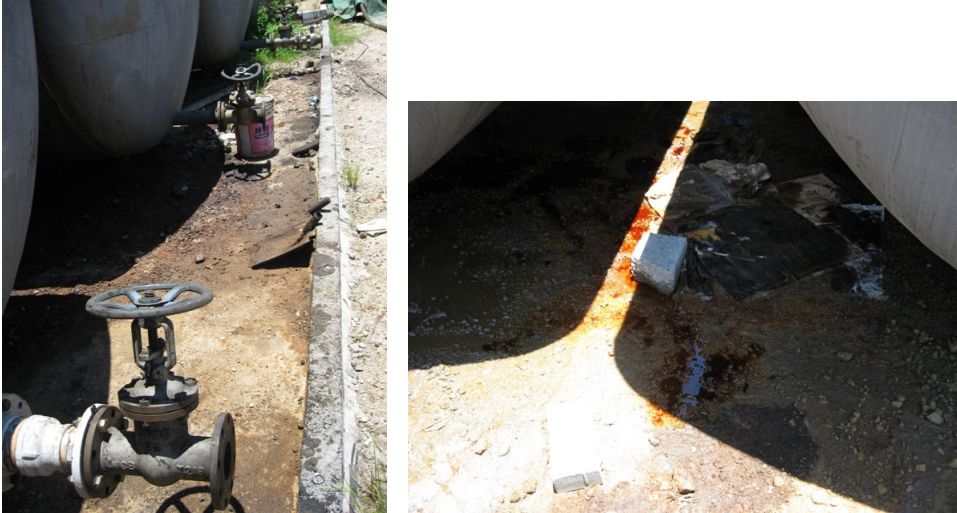
5 July 2010
No.	Follow-up from Previous Audit Dated <u>25 May 2010</u> (Please state date of previous audit)	Completed / Outstanding?
1	<p>At the reserved area for EcoPark's WWTP, oil stain was observed near the storage tanks. In addition, uncovered waste cooking oil bucket was observed on the bare ground. The tenant was again reminded to remove the oil stain and dispose of the waste properly, and provide cover to the buckets as well as drip tray / canvas underneath the storage tanks.</p>

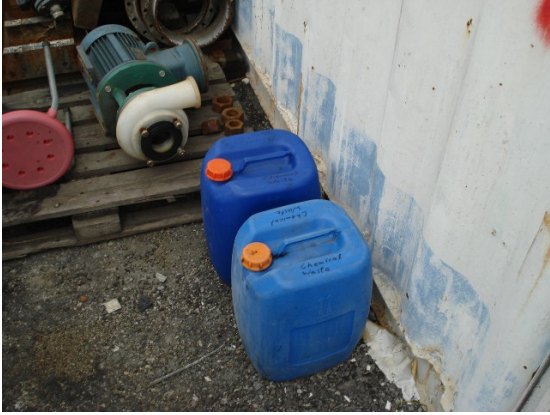
No.	Observation (Please include location and recommended remedial action)	Expected Date for Action Taken
1	<p>Chemicals which were improperly labeled as “chemical waste” were placed on the bare ground. The containers should be properly labeled to avoid any misunderstanding. The tenant was also reminded to put all the chemicals at a proper storage area.</p>

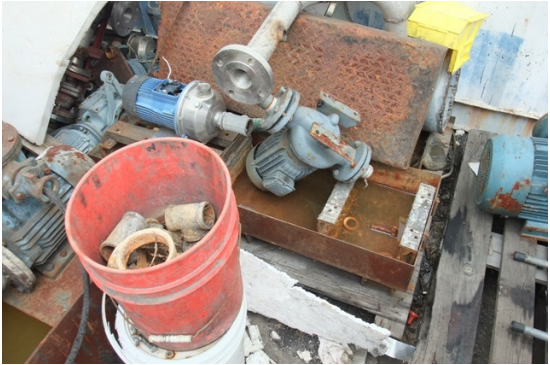
3 August 2010
2	<p>Stagnant water was found on equipments. The tenant was reminded to remove the stagnant water as soon as possible so as to prevent mosquito breeding.</p>

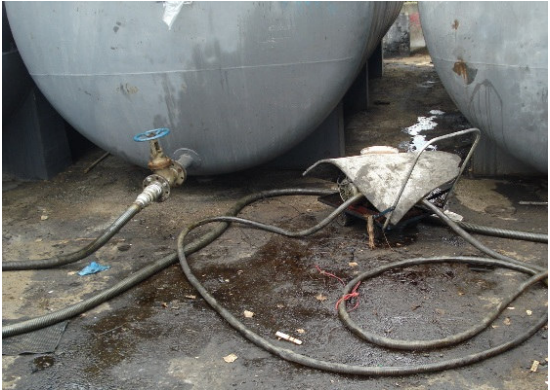
3 August 2010
No.	Follow-up from Previous Audit Dated <u>21 June 2010</u> (Please state date of previous audit)	Completed / Outstanding?
1	<p>Oil stain was still found near the storage tanks inside the lot. The tenant was again reminded to cover the stain by sand and dispose of the sand properly.</p>

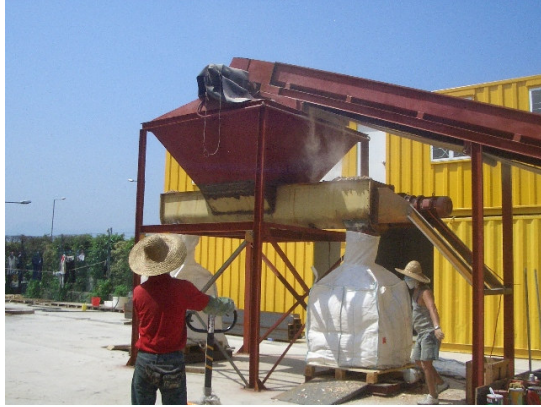
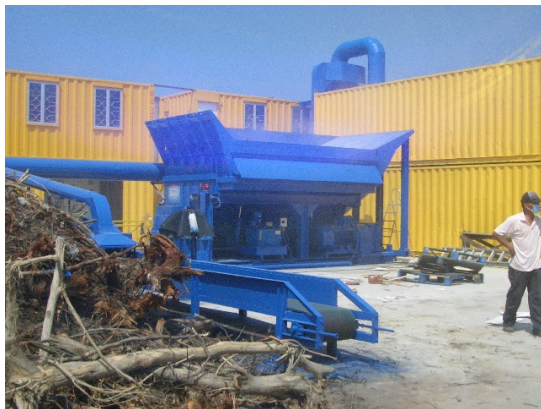
3. Dusty operation was found inside Hung Wai's lot. As advised by the tenant, the plant was undergoing pilot operation and dust suppression unit was in use. The tenant was reminded to provide enclosures made by canvas around the dust-generating activities.

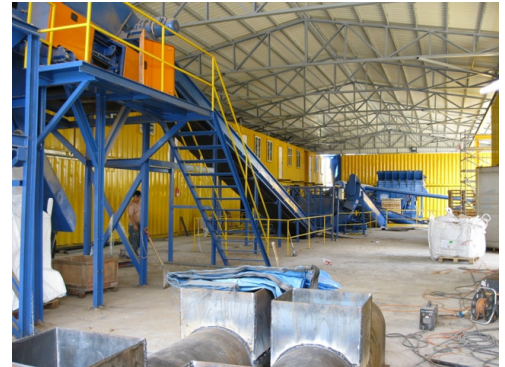
As observed during the site inspection on 21 June 2010, a shelter has been placed above machines. Since the machines were not in operation during the site inspection, the effectiveness of dust suppression unit could not be assessed. The progress of mitigation measures shall be followed-up in the next Monthly Site Audit. (Outstanding)

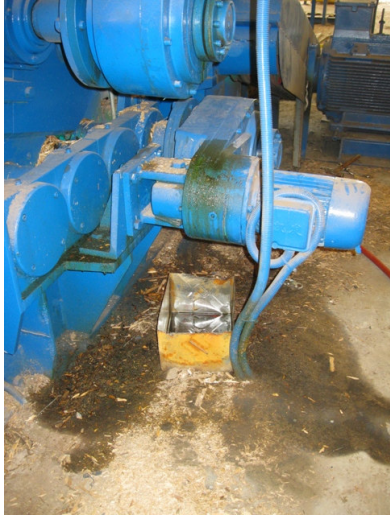
ET Findings / Recommendations (21 June 2010)	Operator / Tenant's Follow-up Actions
<p>1. Oil stain was found near the machines inside the lot. The tenant was reminded to cover the stain by sand and dispose of the sand properly.</p>

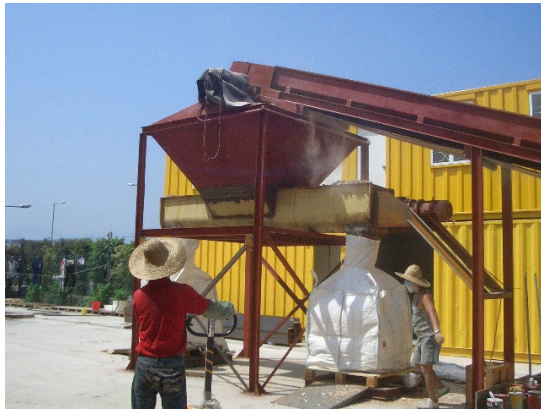
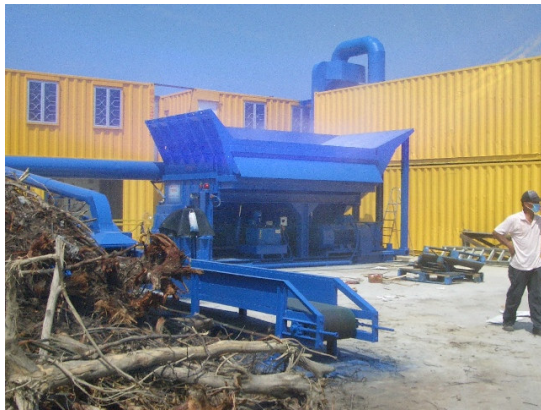
3. Dusty operation was found inside Hung Wai's lot. As advised by the tenant, the plant was undergoing pilot operation and dust suppression unit was in use. The tenant was reminded to provide enclosures made by canvas around the dust-generating activities.

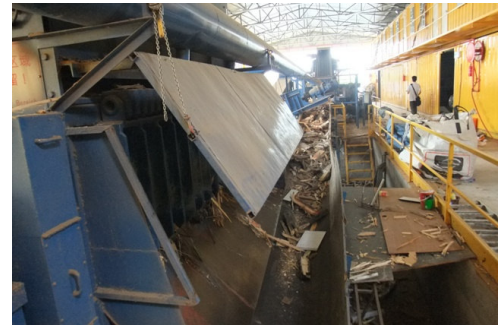
A shelter has been placed above the machines since June 2010. Since the machines were not in operation during the site inspection on 26 July 2010, the effectiveness of dust suppression unit could not be assessed. The progress of mitigation measures shall be followed-up in the next Monthly Site Audit. (Outstanding)

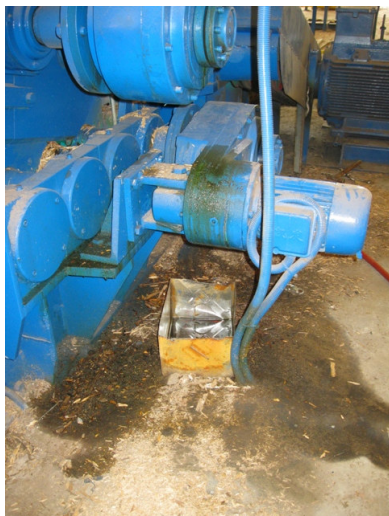
4. Oil stain was found near the machines inside Hung Wai's lot. The tenant was reminded to cover the stain by sand and dispose of the sand properly.

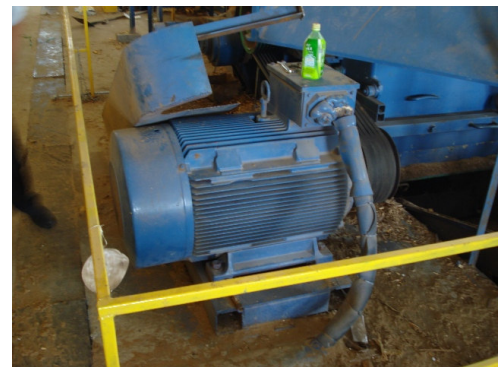
During the site inspection on 26 July 2010, no oil stain was found inside Hung Wai's lot. (Closed)

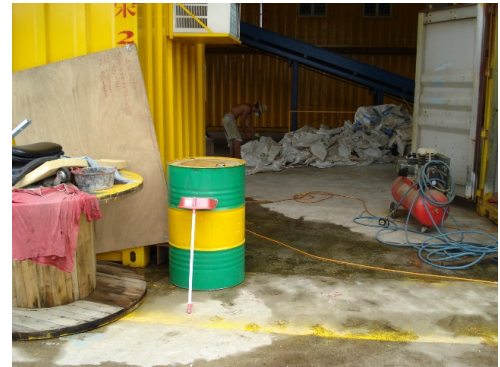
During the site inspection on 26 July 2010, water dripping from air-conditioners was still found inside Hung Wai's lot. Besides collecting the dripped water, the tenant was suggested to spray mosquito larvicidal oil on stagnant water. (Outstanding)

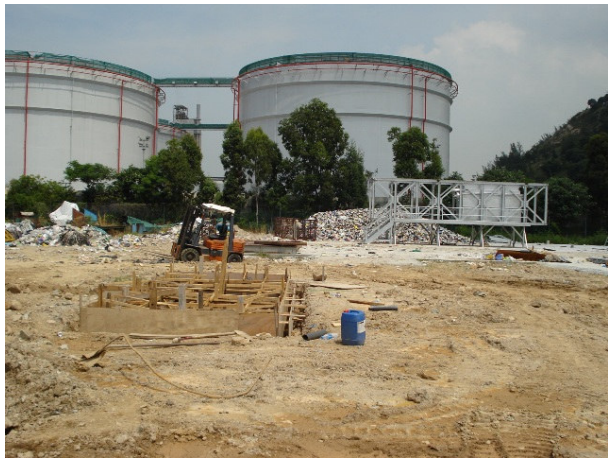
ET Findings / Recommendations (26 July 2010)	Operator / Tenant's Follow-up Actions
<p>1. Chemicals were found on the bare ground inside Telford's lot. The tenant was reminded to provide drip tray to all chemicals.</p>

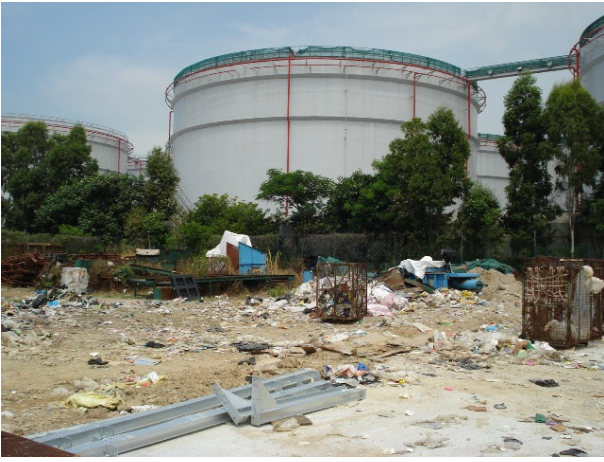
<p>2. The received plastics lied around Telford's lot. The tenant was reminded to enhance housekeeping.</p>

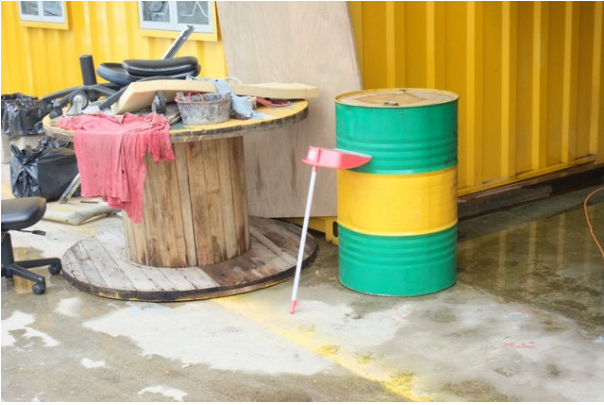
<p>To be found out in the next Monthly Site Audit.</p>
<p>3. Chemicals were found on the ground inside Hung Wai's lot. The tenant was reminded to provide drip tray to all chemicals.</p>

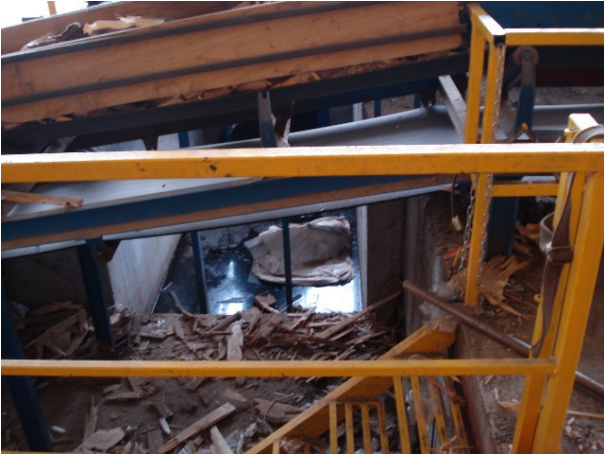
<p>To be found out in the next Monthly Site Audit.</p>
<p>4. Stagnant pool of water was found underneath the machines inside Hung Wai's lot. The tenant was reminded to clear the water to prevent mosquito breeding.</p>

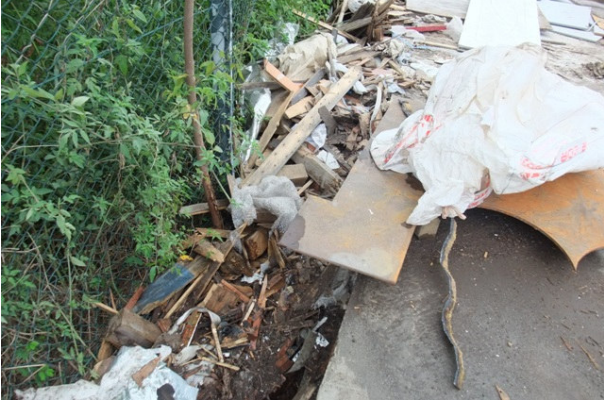
<p>5. The drain next to Hung Wai's boundary was blocked. The tenant was reminded to remove the materials and provide regular maintenance to the drainage system.</p>

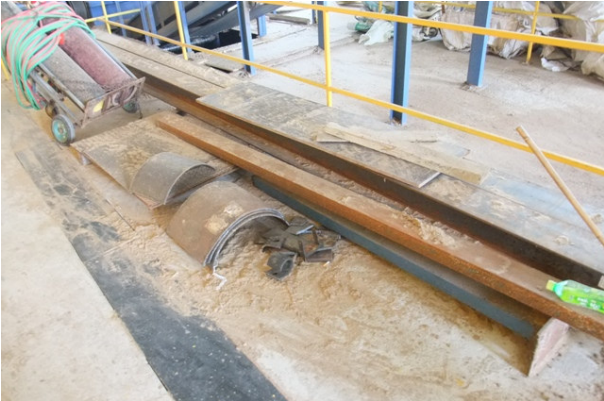
<p>To be found out in the next Monthly Site Audit.</p>
<p>6. Sawdust was found near the machines inside Hung Wai's lot. Since the sawdust has been cleared on a daily basis, the tenant was reminded to remove the sawdust more frequently.</p>

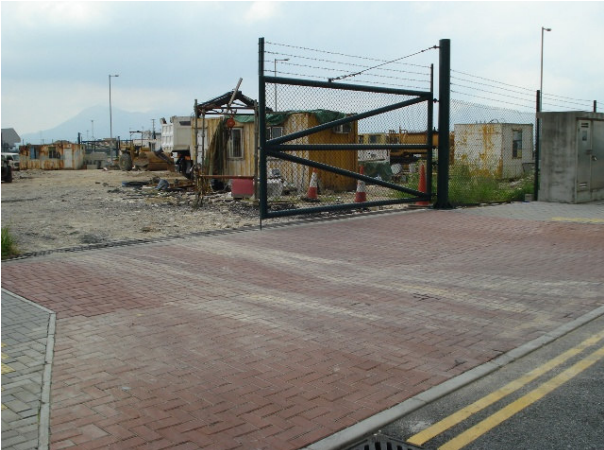
<p>To be found out in the next Monthly Site Audit.</p>
<p>7. Muddy trail was found outside the lot of "P10". SGJV was advised to liaise with the RE for clearing the trail and providing suitable measures e.g. wheel washing facilities at exits if necessary.</p>

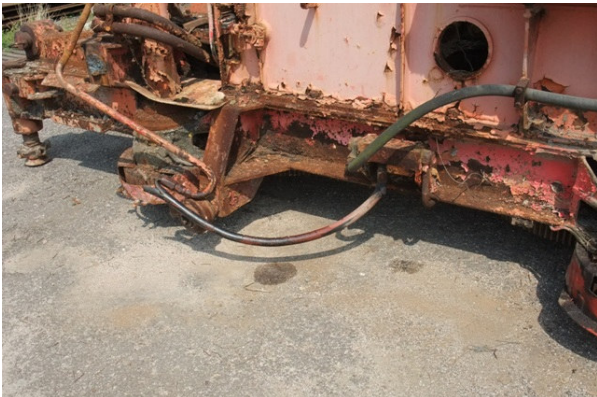
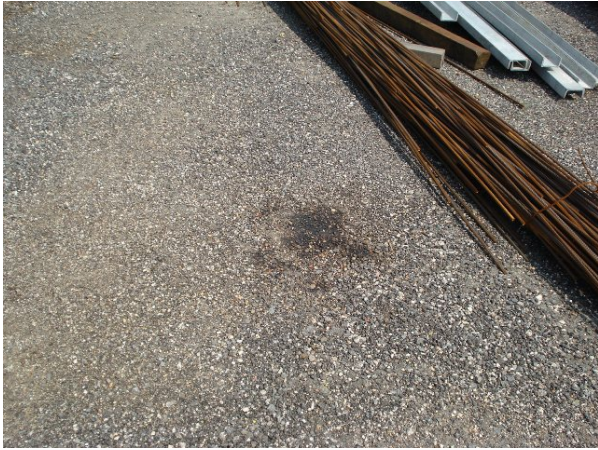
No.	Observation (Please include location and recommended remedial action)	Expected Date for Action Taken
1	<p>Oil stain was found at various locations inside the lot. The tenant was reminded to cover the stain by sand and dispose of the sand properly. To prevent land contamination from oil leakage, more steel board should be used to cover the lot.</p>

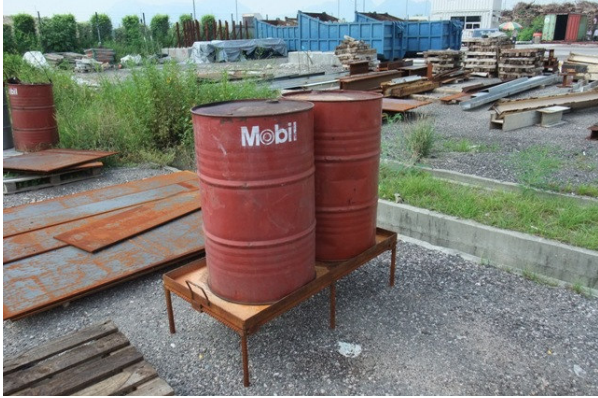
2	<p>Temporary stored chemical drums were found without cover. The tenant was reminded to store these chemicals with full cover to prevent rain water flushing the chemicals down the ground.</p>
