# EcoPark Operation

## Annual EM&A Compliance Report

January to December 2010

Project/Deliverable Number:	J494A   D02/01
Project Name:	EcoPark Operation EM&A
Report Name:	Annual EM&A Compliance Report – January to December 2010
Report Date:	17 March 2011
Report for:	Serco Guardian JV

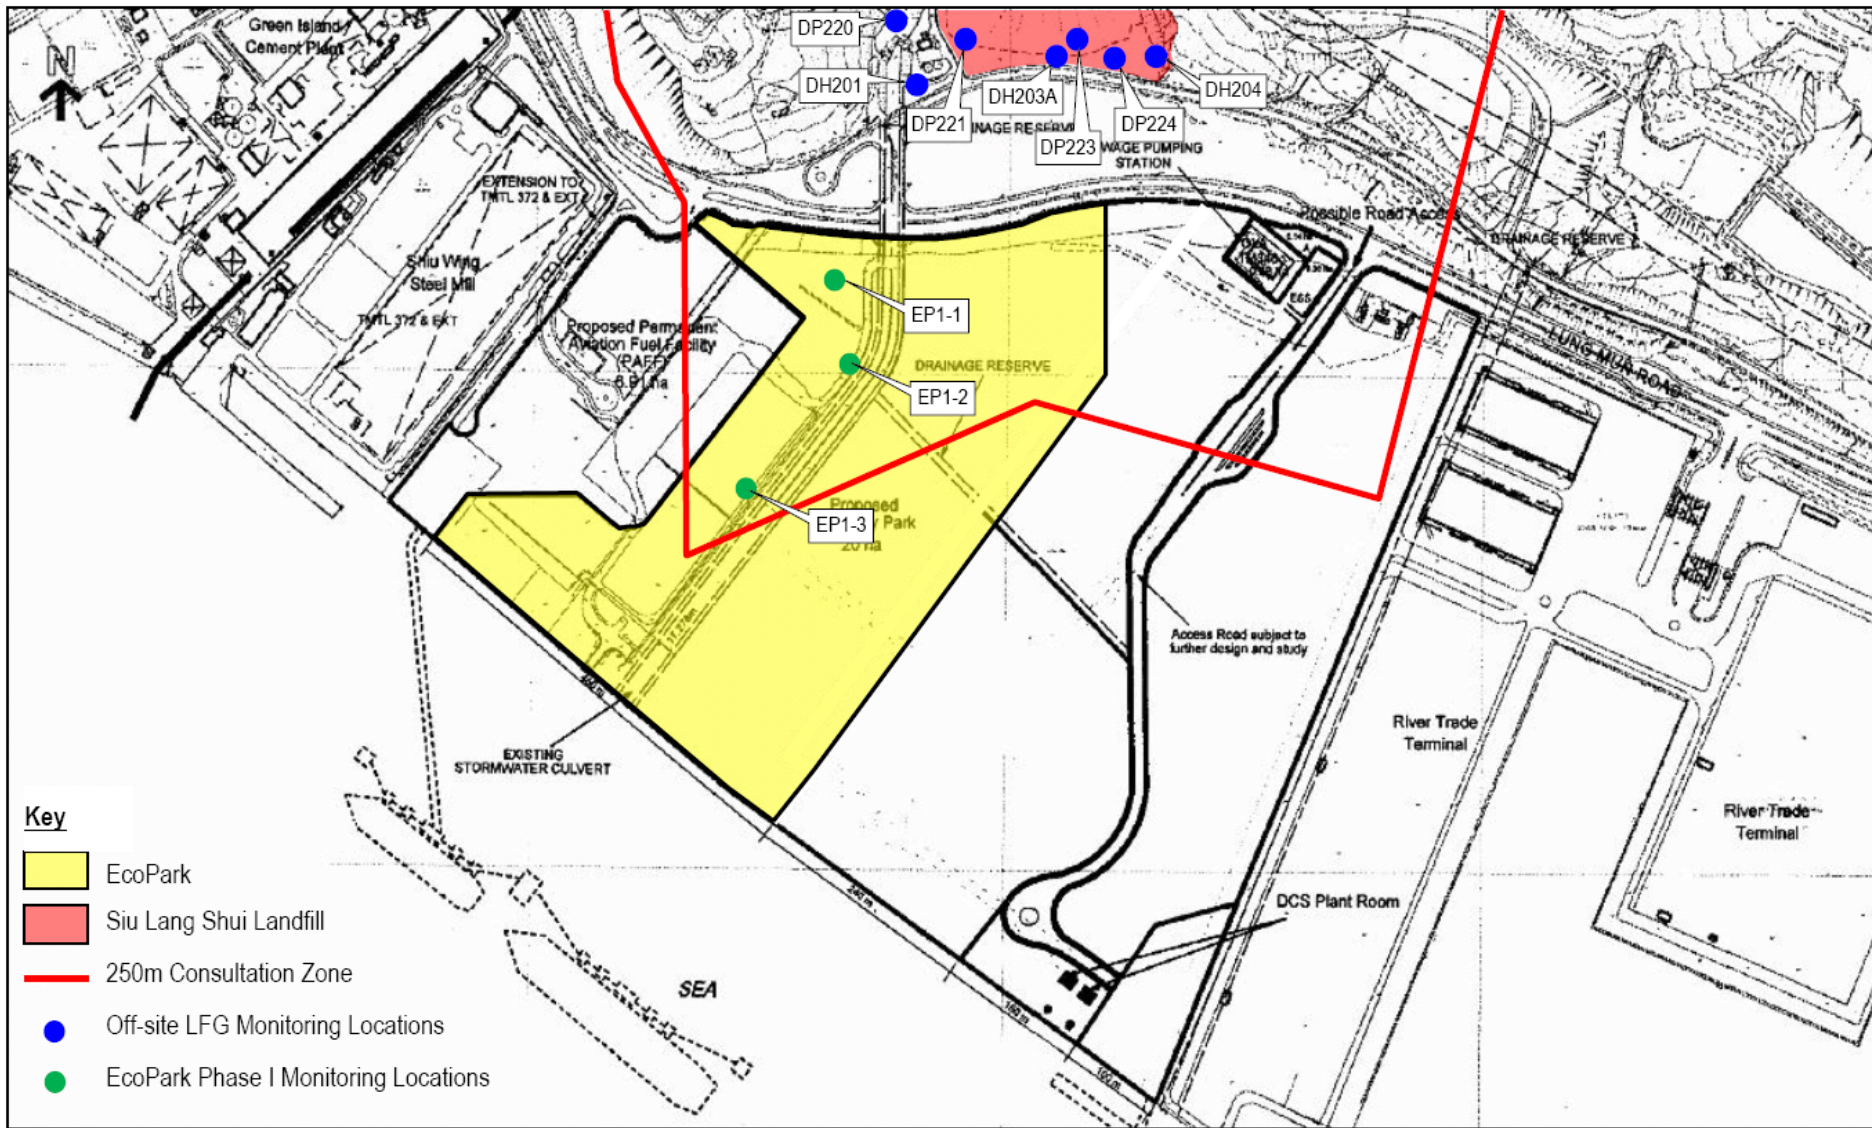
Figure 2-2 Replacement Figure for EM&A Manual Figure 6.1

Figure 6.1 of the EM&A Manual has also been updated and replaced by **Figure 2-2** showing the off-site LFG monitoring locations at Siu Lang Shui Landfill and on-site LFG monitoring at EcoPark.
