# EcoPark Operation Annual EM&A Compliance

January to December 2012

## Annual EM&A Compliance Report

Project/Deliverable No:	J494A   D02/ 04
Project Name:	EcoPark Operation EM&A
Report Name:	Annual EM&A Compliance Report – January to December 2012
Report Date:	July 2013
Report for:	Serco Guardian JV

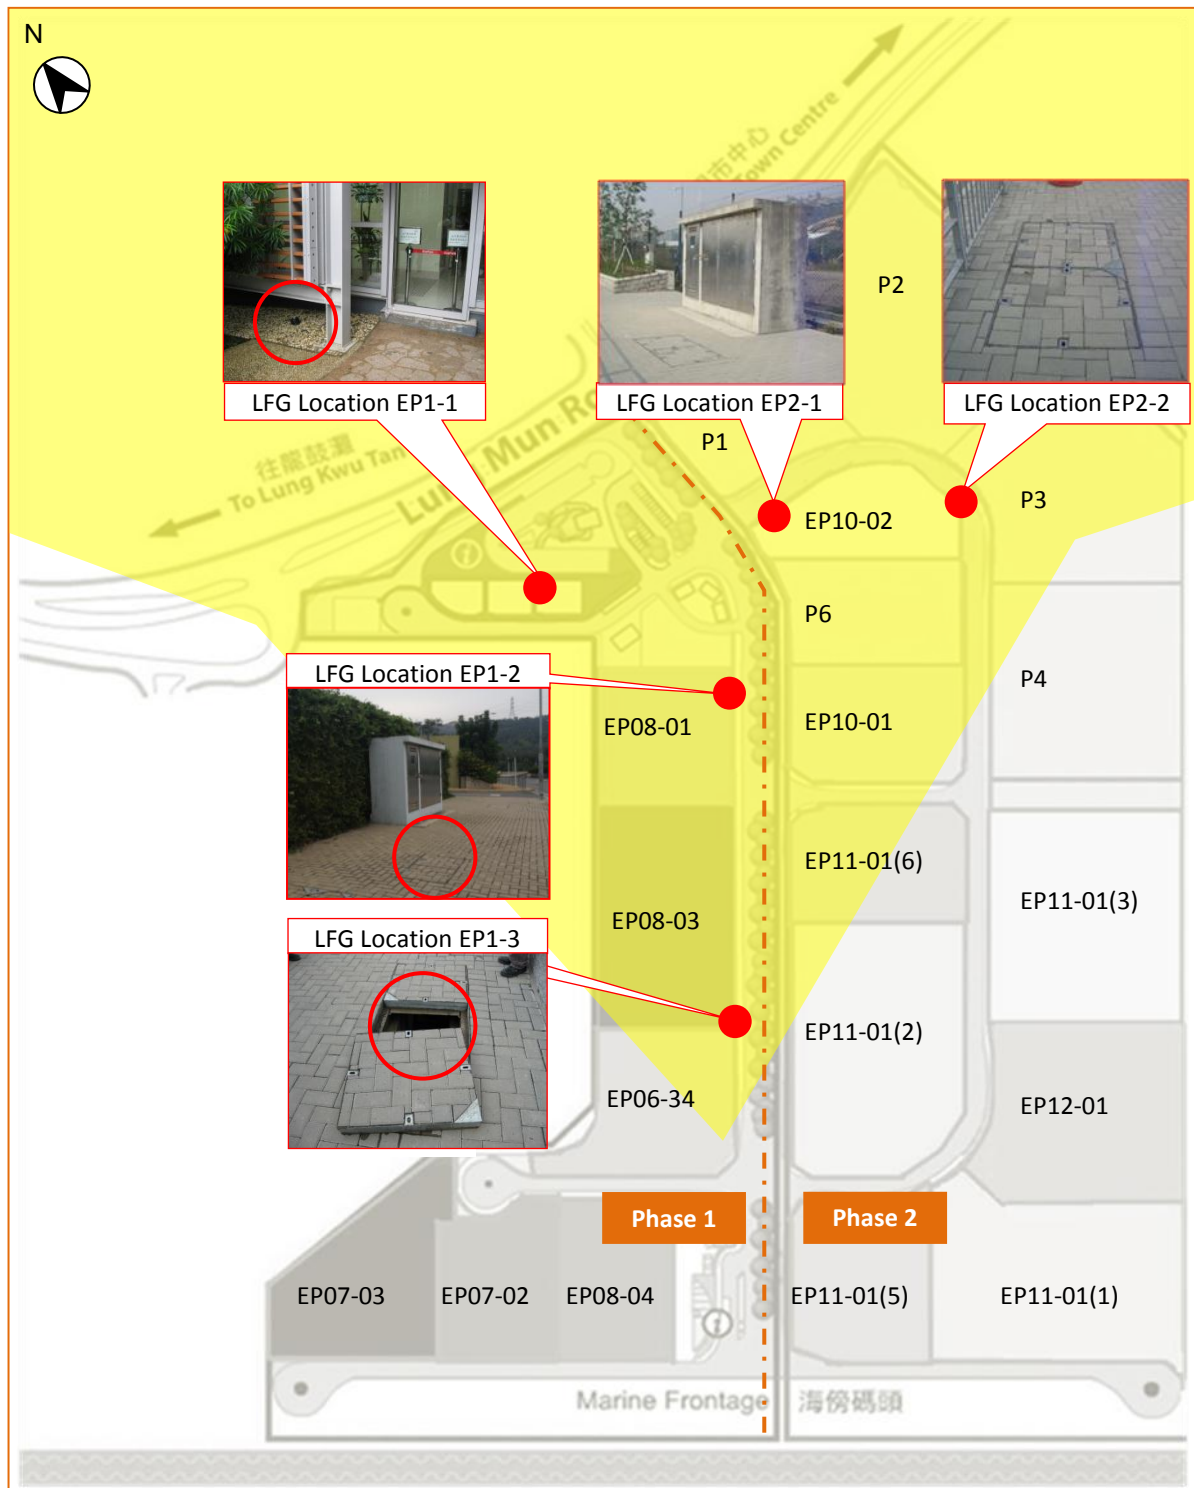
**Figure 2-1 LFG Monitoring Locations within EcoPark**

Area Within the Shiu Lang Shui Landfill Gas Consultation Zone
