EcoPark Operation

Annual EM&A Compliance Report 2013

Project/Deliverable No:	7076026 D02/04 – Revision 4
Project Name:	EcoPark Operation EM&A
Report Name:	Annual EM&A Compliance Report 2013
Report Date:	May 2014
Report for:	Serco Guardian JV

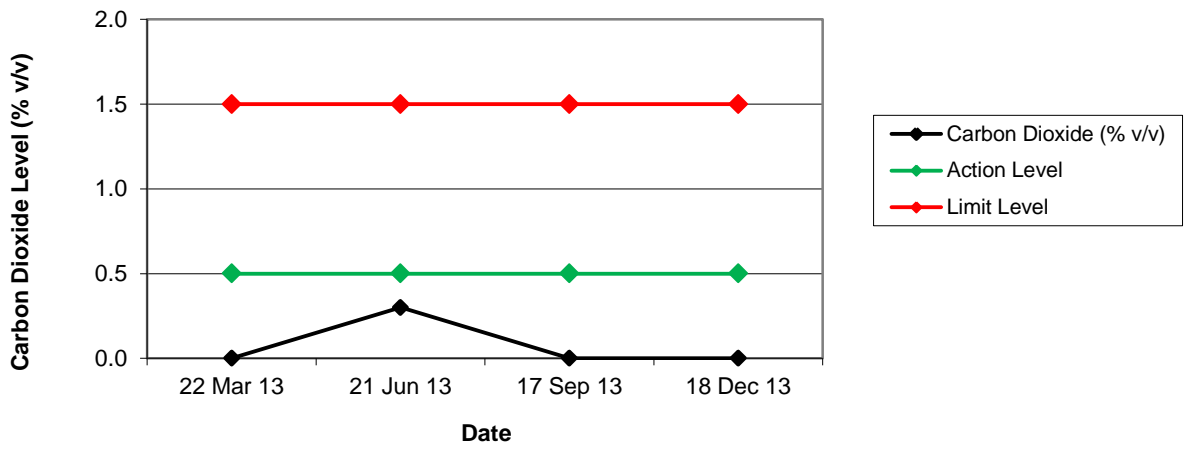
Measured Carbon Dioxide Level (% v/v) at EP2-2

5.4.2 One exceedance of Action Level for oxygen (18%) was recorded at EP2-2 on 21 June 2013. Carbon dioxide concentration was slightly elevated at 0.3% but methane concentration was 0%. The slightly lower level of oxygen and slightly higher level of carbon dioxide at EP2-2 may indicate natural decay of organic material in the service void, however, since no methane was detected it can be concluded that the exceedance at EP2-2 was not related to migration of LFG from Shiu Lang Shui Landfill.
