Development of EcoPark in Tuen Mun Area 38

Contract No. EP/SP/52/06
EM&A Report No. 33 (March 2009)

ENVIRONMENTAL MONITORING AND AUDIT

MONTHLY EM&A REPORT for

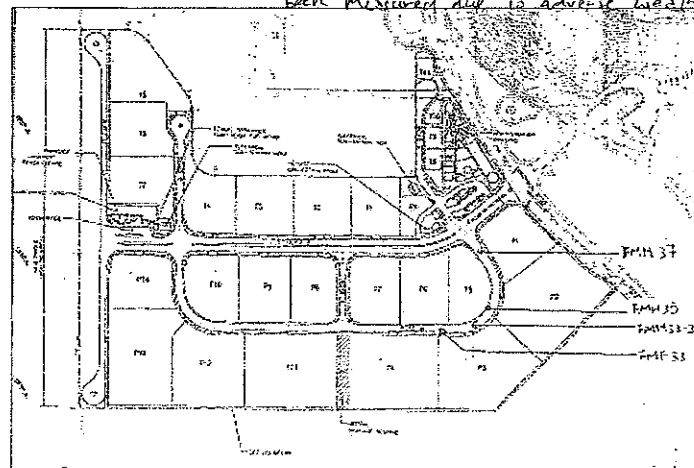
Date of Monitoring: 06 Mar 2009
 Weather condition: Rainy
 Monitoring performed by: Chung Pui Sun
 Monitoring instrument:

Instrument for O₂ measurement: GasAlert MicroClip GAMIC-4-DL2 Serial no.: S103-13348

* Monitoring point FMH 33, 33-34 and 35 have not been measured due to adverse weather conditions.

Sampling Location	Date of Measurement	Sampling Time	Weather Condition	Methane (CH ₄) %LEL	Carbon Dioxide (CO ₂) %LEL	Oxygen (O ₂)
FMH 37	06 March 09	11:20	Rainy	0.00%	0.00%	20.9
FMH 35	06 March 09	N/A*	N/A*	N/A*	N/A*	N/A*
FMH 33 – 34	06 March 09	N/A*	N/A*	N/A*	N/A*	N/A*
FMH 33	06 March 09	N/A*	N/A*	N/A*	N/A*	N/A*
FMH 37	13 March 09	10:22	Sunny	0.00%	0.00%	N/A**
FMH 35	13 March 09	10:28	Sunny	0.00%	0.00%	N/A**
FMH 33 – 34	13 March 09	10:32	Sunny	0.00%	0.00%	N/A**
FMH 33	13 March 09	10:35	Sunny	0.00%	0.00%	N/A**
FMH 37	20 March 09	12:09	Drizzle	0.00%	0.00%	22.2%
FMH 35	20 March 09	12:19	Drizzle	0.00%	0.00%	22.7%
FMH 33 – 34	20 March 09	12:24	Drizzle	0.00%	0.00%	22.7%
FMH 33	20 March 09	12:30	Drizzle	0.00%	0.00%	20.9%
FMH 37	27 March 09	11:25	Overcast	0.00%	0.00%	20.9%
FMH 35	27 March 09	11:29	Overcast	0.00%	0.00%	20.9%
FMH 33 – 34	27 March 09	11:32	Overcast	0.00%	0.00%	20.9%
FMH 33	27 March 09	11:35	Overcast	0.00%	0.00%	20.9%

* Monitoring point FMH 33, 33-34 and 35 have not been measured due to adverse weather conditions.

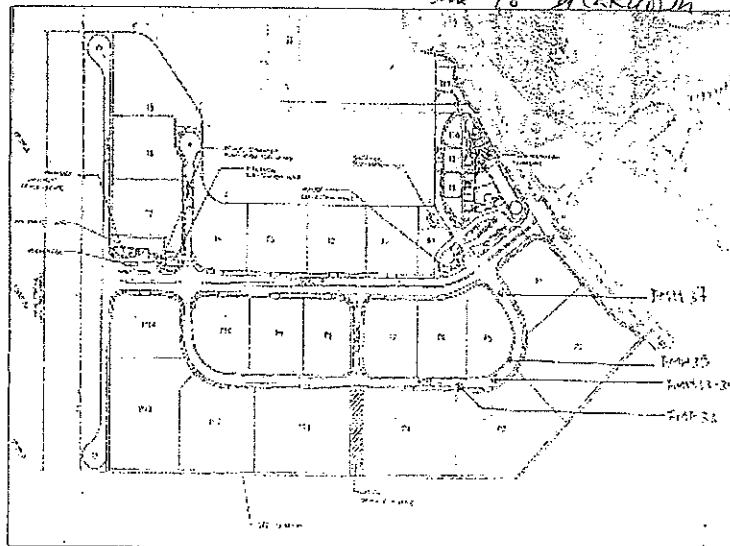
Date of Monitoring: 13/3/2009
 Weather condition: Sunny
 Monitoring performed by: Chung Pui Suen
 Monitoring instrument:

Instrument for O₂ measurement: GasAlert MicroClip GAMIC-4-DL2 Serial no.: S103-13348

*O₂ meter was unavailable due to breakdown

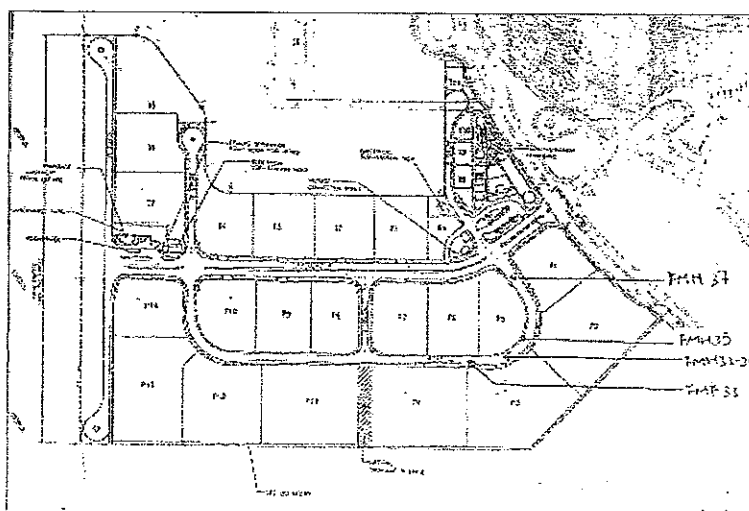
Location	Time	Results				
		Methane (CH ₄) %	Carbon Dioxide (CO ₂) %	*Oxygen (O ₂) %	Bal. Gas %	Baro. Pressure %
FMH 33	12:30	00.0	00.0	20.9	85.2	29.83
FMH 33 - 34	12:24	00.0	00.0	22.7	85.4	29.83
FMH 35	12:19	00.0	00.0	22.7	85.2	29.83
FMH 37	12:09	00.0	00.0	22.2	85.0	29.83

Instrument for O₂ measurement: GasAlert MicroClip GAMIC-4-DL2 Serial no.:S103-13348
 *O₂ level measured with GasAlert Micro

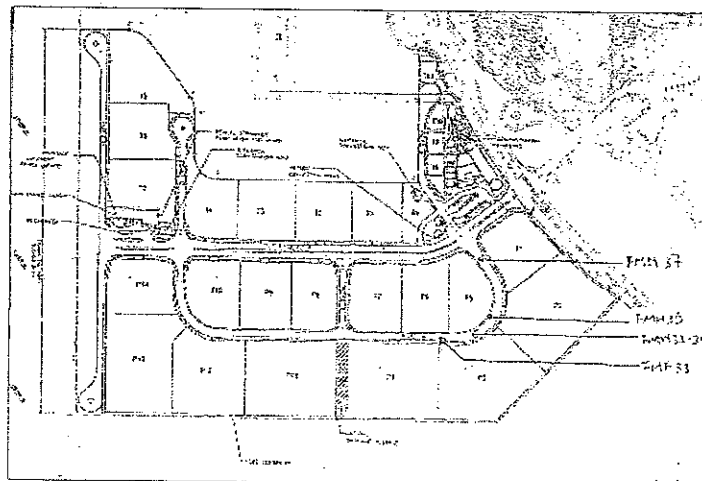
Weather condition: Overcast

Location	Time	Results				
		Methane (CH ₄) %	Carbon Dioxide (CO ₂) %	Oxygen (O ₂) %	Bal. Gas %	Baro. Pressure %
FMH 33	11:25	0.00	0.00	20.9	84.85	30.02
FMH 33-34	11:30	0.00	0.00	20.9	84.85	30.02
FMH 35	11:29	0.00	0.00	20.9	84.85	30.02
FMH 37	11:25	0.00	0.00	20.9	84.85	30.02

Instrument for O₂ measurement: GasAlert MicroClip GAMIC-4-DL2 Serial no.:S103-13348
