**Contract No. : EP/SP/52/06**  
**Development of an EcoPark in Tuen Mun Area 38**

**ENVIRONMENTAL MONITORING AND AUDIT**

**MONTHLY EM&A REPORT for**

**APRIL 2007**

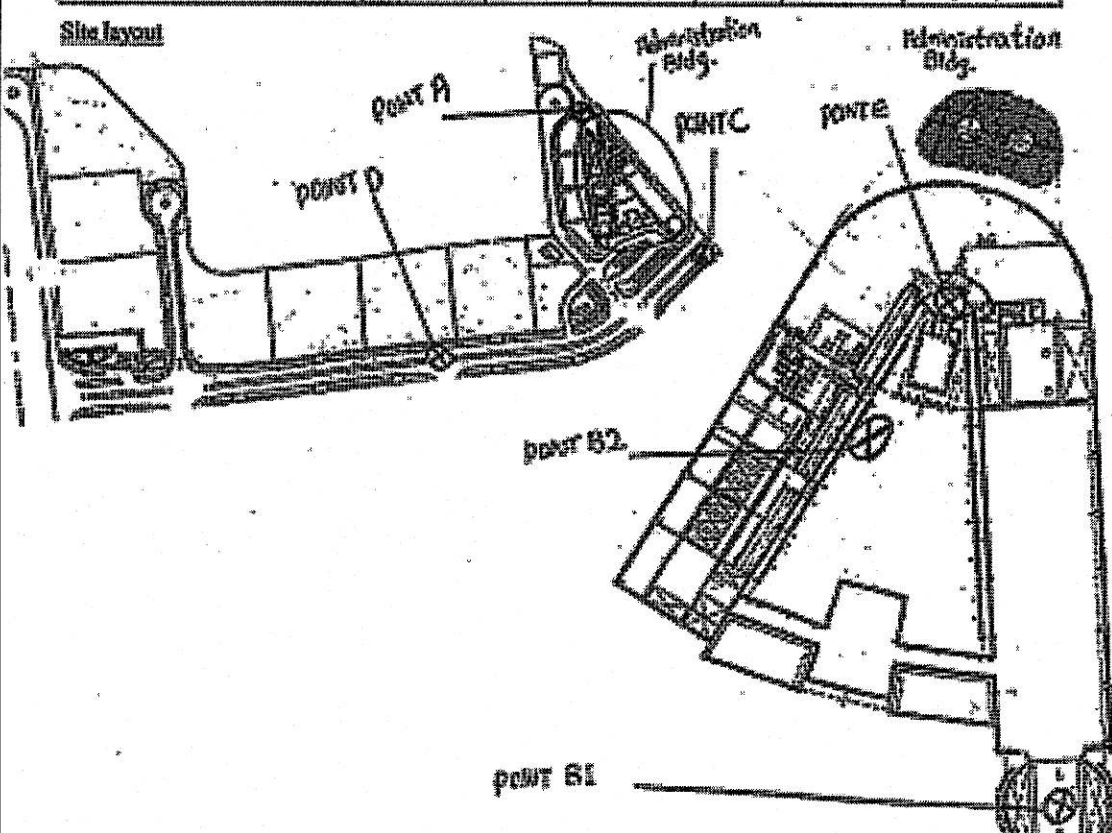
**Site layout**

Location 位置	Time 時間 (hrs)	Result 結果				
		CH <sub>4</sub> (%)	CO <sub>2</sub> (%)	O <sub>2</sub> (%)	Rel. Gas (%)	Baro. Pressure (mmHg)
Point A	1445	0.0	0.0	18.3	81.7	29.95
Point B1	1454	0.0	0.0	18.2	81.7	29.95
Point B2 (GL3-5/E)	1451	0.0	0.0	18.2	81.7	29.95
Point C1 (FMH044)	1456	0.0	0.0	18.2	81.8	29.95
Point D	1500	0.0	0.0	18.1	81.8	29.95
Point E (E&M room)	1447	0.0	0.0	18.3	81.6	29.95

The site layout diagram illustrates the spatial arrangement of monitoring points. Point A is located near the top left, Point B1 and B2 are in the center, Point C1 is to the right, Point D is at the bottom left, and Point E is at the bottom right. The Administration Bldg. is shown as a large structure in the upper right, and a circular feature is visible in the lower right.
