Contract No. : EP/SP/52/06
Development of an EcoPark in Tuen Mun Area 38

ENVIRONMENTAL MONITORING AND AUDIT

MONTHLY EM&A REPORT for

FEBRUARY 2007

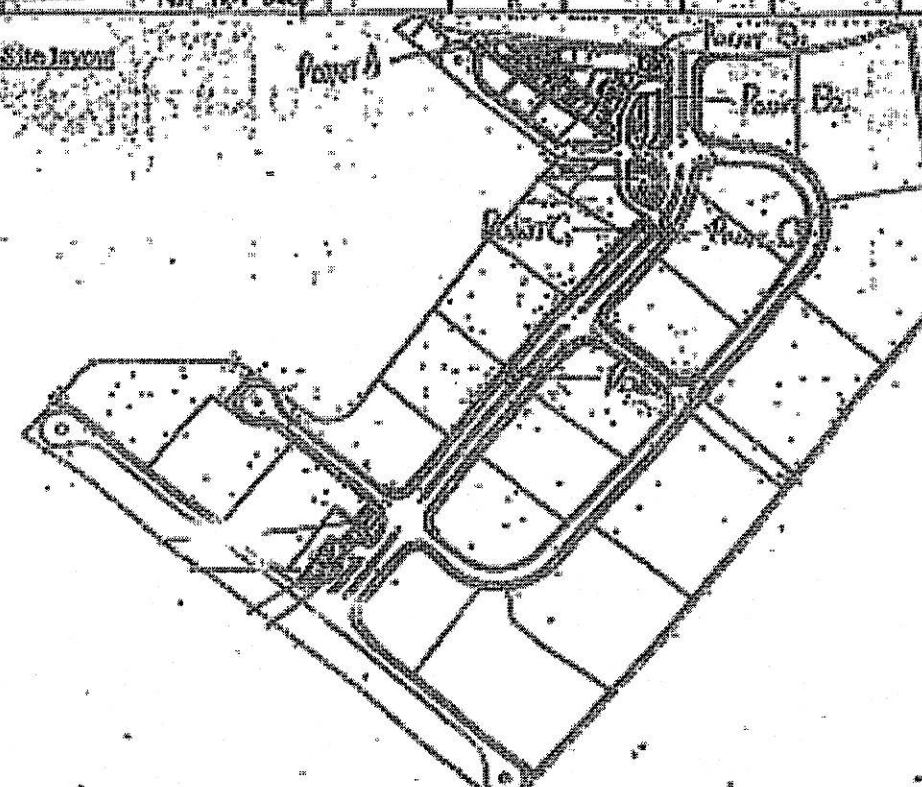
Location 位置	Time 時間 (hrs)	Result 結果				
		CH ₄ (%)	CO ₂ (%)	O ₂ (%)	Rel. Gas (%)	Baro. Pressure (mmHg)
Point A	13:00	0	0	17.9	82.0	30.33
Point B1	12:45	0	0	18.0	82.1	30.27
Point B2 (Water retention tank)	12:30	0	0	17.8	82.2	30.28
Point C1 (FM11001)	12:30	0	0	17.8	82.2	30.27
Point C2 (FM11000)	12:45	0	0	17.8	82.2	30.27
Point D	No. 1 km away

Site layout diagram showing monitoring points A, B1, B2, C1, C2, and D. The diagram includes a grid and various site features.

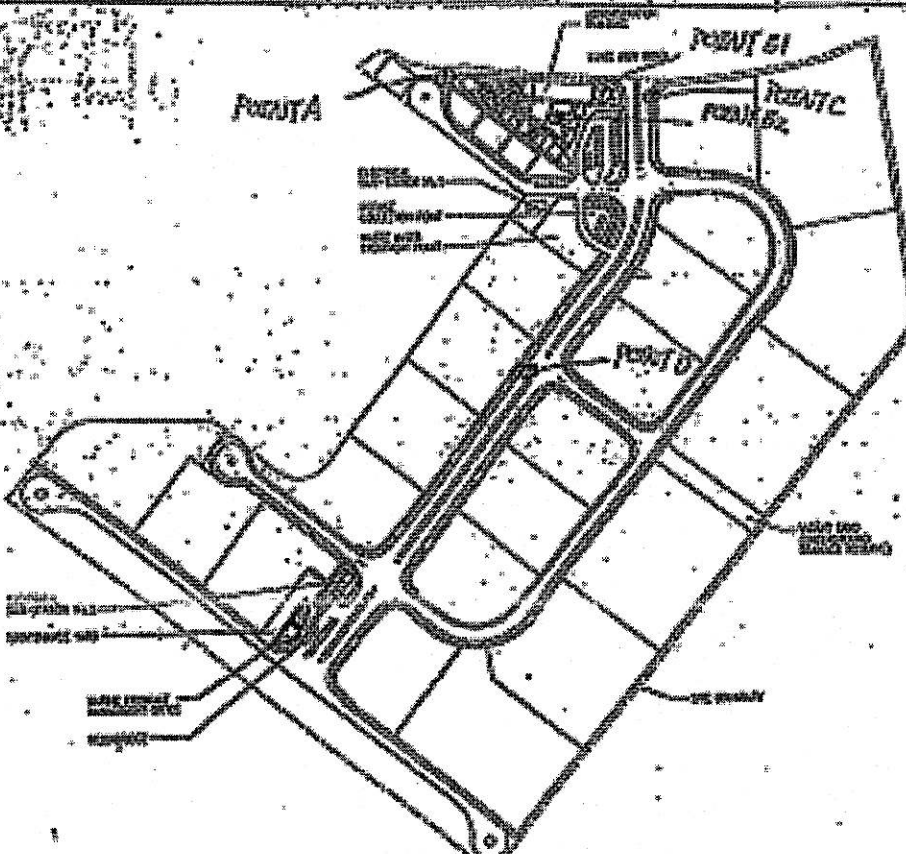
Location 位置	Time 時間 (hr)	Result 結果				
		CH ₄ (%)	CO ₂ (%)	O ₂ (%)	Hum. Gaz (%)	Baro. Pressure (hPa)
Point A	15:52	0	0	18.1	81.5	29.95
Point B1	16:36	0	0	17.9	82.0	29.95
Point B2 (Rainwater retention tank)	17:07	0	0	18.0	82.0	29.95
Point C1 (EMEPM)	18:47	0	0	18.0	81.9	29.95
Point D	18:02	0	0	17.8	81.1	29.95

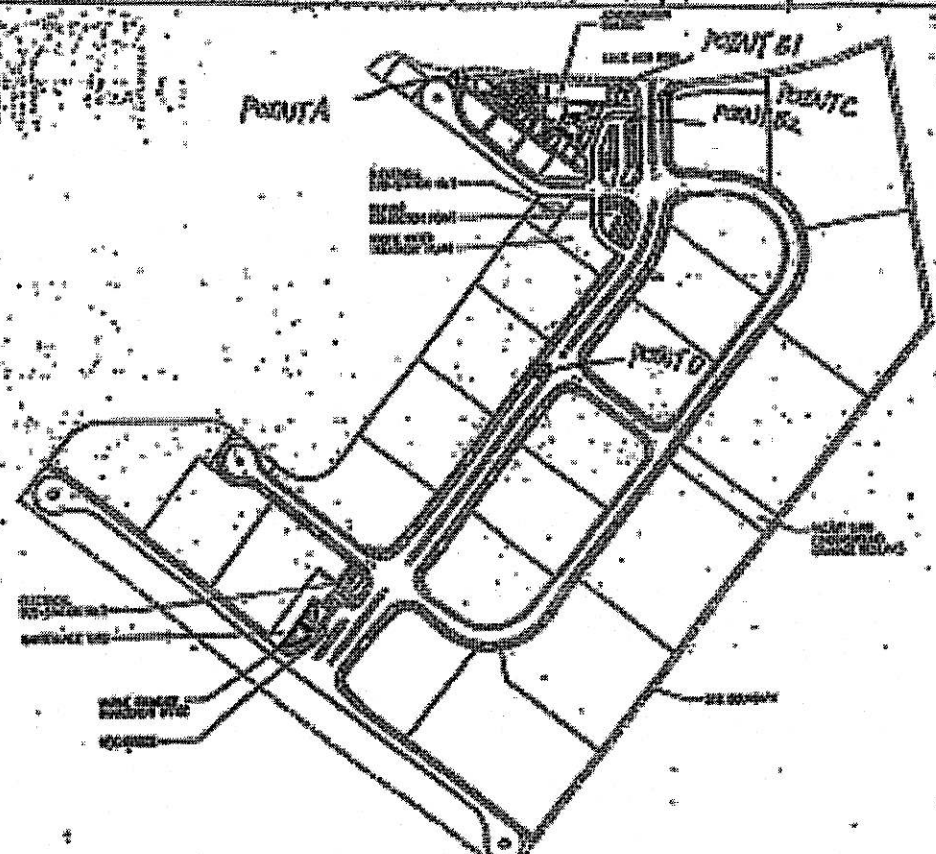
Site Layout

Location 位置	Time 時間 (hr)	Result 結果				
		CH ₄ (%)	CO ₂ (%)	O ₂ (%)	Rel. Gas (%)	Baro. Pressure (hPa)
Point A	1510	0	0	18.0	82.0	29.88
Point B1	1511	0	0	17.9	82.1	29.87
Point B2 (rainwater retention tank)	1515	0	0	17.9	82.0	29.88
Point C1 (EMHPT)	1522	0	0	17.9	82.0	29.87
Point D	1527	0	0	17.7	82.2	29.88
