**Contract No. : EP/SP/52/06**  
**Development of an EcoPark in Tuen Mun Area 38**

**ENVIRONMENTAL MONITORING AND AUDIT**

**MONTHLY EM&A REPORT for**

**JANUARY 2007**

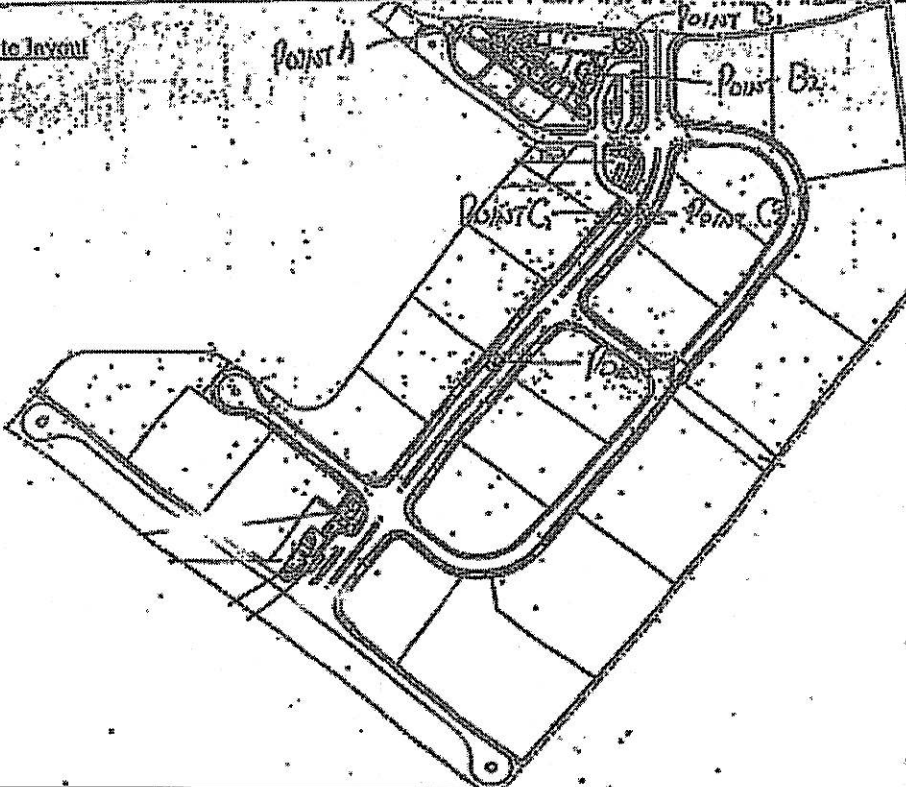
Site layout

Location 位置	Time 時間 (hrs)	Result 結果				
		CH <sub>4</sub> (%)	CO <sub>2</sub> (%)	O <sub>2</sub> (%)	Bal. Gas (%)	Baro. Pressure (Hg)
Point A	1550	0	0	18.4	81.5	30.14
Point B1	1600	0	0	18.4	81.6	30.14
Point B2 (Rainwater retention tank)	1555	0	0	18.4	81.5	30.14
Point C1 (RME041)	1608	0	0	18.3	81.6	30.14
Point C2 (RME040)	1605	0	0	18.2	81.7	30.14
Point D	1612	0	0	18.4	81.6	30.14
