**Contract No. : EP/SP/52/06**  
**Development of EcoPark in Tuen Mun Area 38**

**ENVIRONMENTAL MONITORING AND AUDIT**

**MONTHLY EM&A REPORT for**

**JULY 2007**

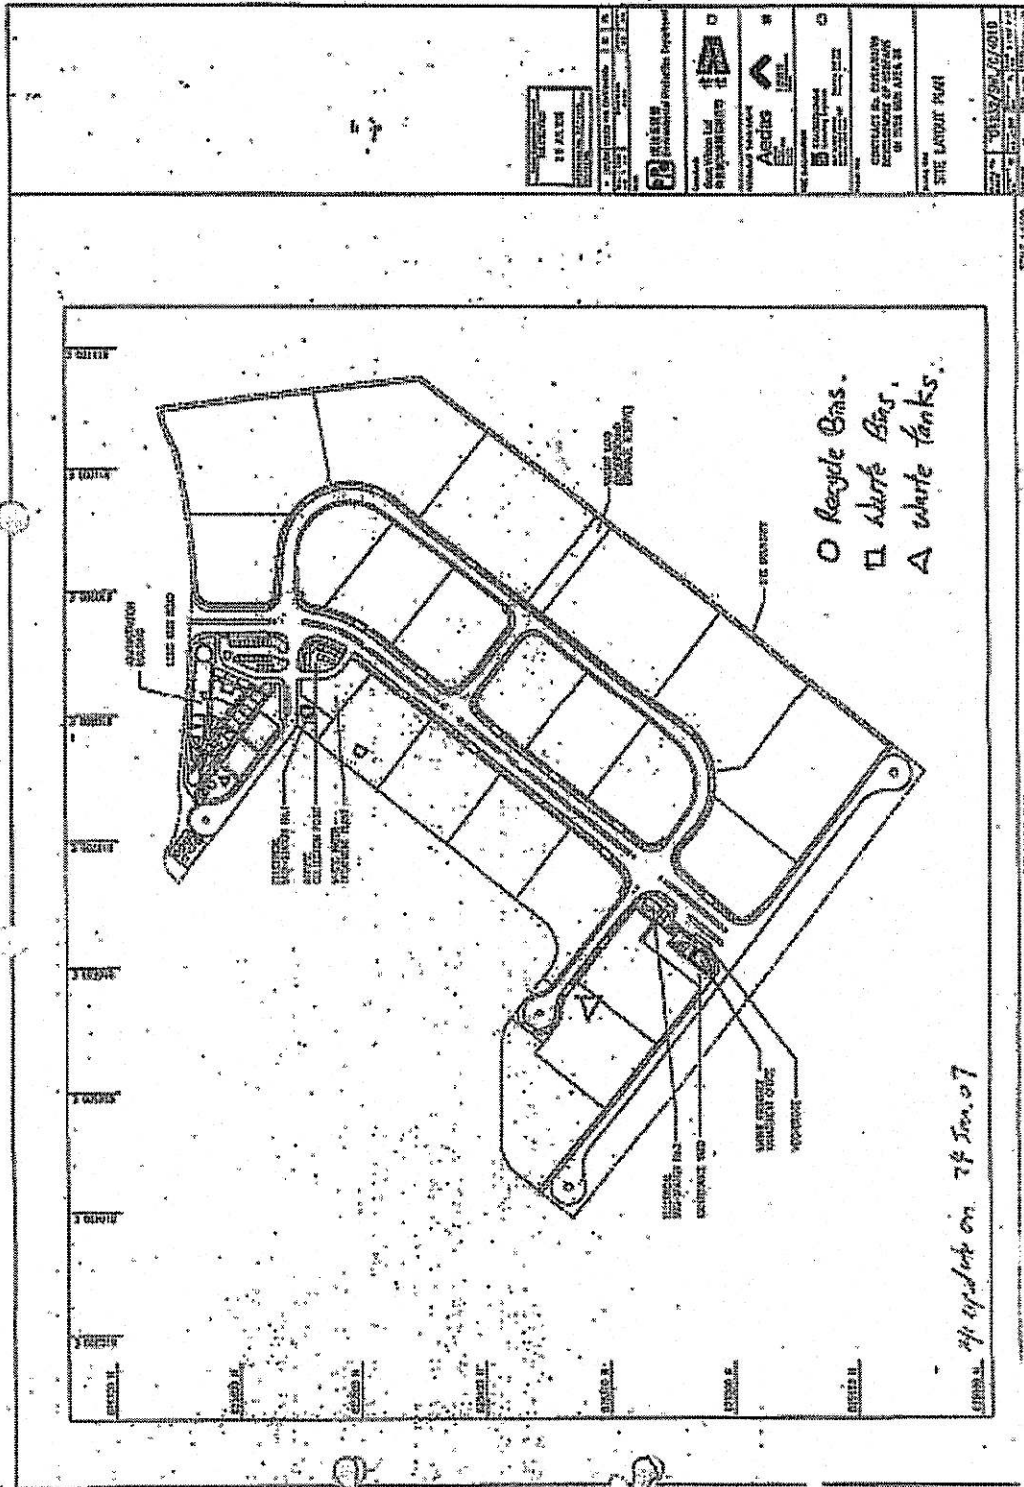
**APPENDIX 3 – SITE LAYOUT PLAN FOR REFUSE COLLECTION POINTS**

SCALE 1:1000

APPENDIX 3 – SITE LAYOUT PLAN FOR REFUSE COLLECTION POINTS .....19
