**Contract No. : EP/SP/52/06**  
**Development of an EcoPark in Tuen Mun Area 38**

**ENVIRONMENTAL MONITORING AND AUDIT**

**MONTHLY EM&A REPORT for**

**MARCH 2007**

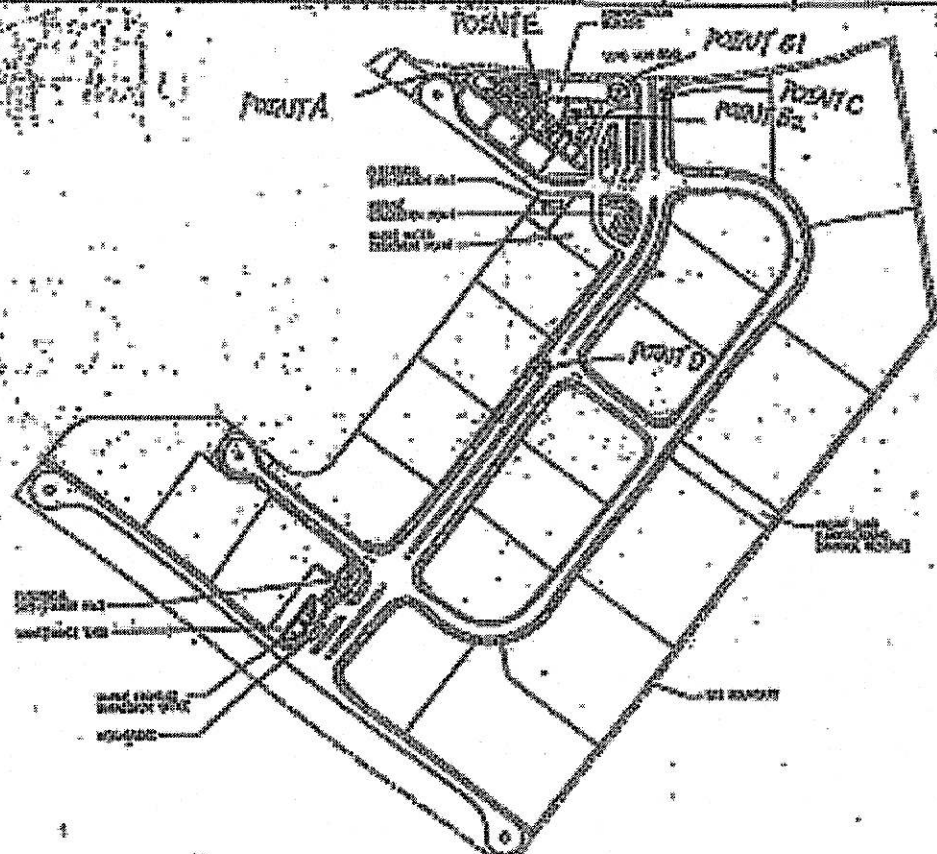
Location 位置	Time 時間 (hrs)	Result 結果				
		CH <sub>4</sub> (%)	CO <sub>2</sub> (%)	O <sub>2</sub> (%)	Rel. Gas (%)	Baro. Pressure (Tls)
Point A	16:52	0	0	18.3	81.6	29.99
Point B1	17:00	0	0	18.6	81.3	29.99
Point B2 (Rainwater retention tank)	16:57	0	0	18.4	81.5	29.99
Point C1 (FRM/PM)	17:02	0	0	18.5	81.4	29.99
Point D	17:06	0	0	18.5	81.5	29.99
Point E	not	not	not	not	not	not

Sampling Location	Date of Measurement	Sampling Time	Weather Condition	Methane (CH <sub>4</sub> ) %LEL	Carbon Dioxide (CO <sub>2</sub> ) %LEL	Oxygen (O <sub>2</sub> )
Point A	08 Mar 07	1652	Cloudy	0.0%	0.0%	18.3%
Point B1	08 Mar 07	1700	Cloudy	0.0%	0.0%	18.6%
Point B2	08 Mar 07	1657	Cloudy	0.0%	0.0%	18.4%
Point C1	08 Mar 07	1702	Cloudy	0.0%	0.0%	18.5%
Point D	08 Mar 07	1706	Cloudy	0.0%	0.0%	18.5%
Point E	Not Accessible					
Point A	14 Mar 07	1601	Cloudy	0.0%	0.0%	17.9%
Point B1	14 Mar 07	1550	Cloudy	0.0%	0.0%	18.0%
Point B2	14 Mar 07	1547	Cloudy	0.0%	0.0%	18.0%
Point C1	14 Mar 07	1552	Cloudy	0.0%	0.0%	18.0%
Point D	14 Mar 07	1556	Cloudy	0.0%	0.0%	18.0%
Point E	14 Mar 07	1545	Cloudy	0.0%	0.0%	18.0%
Point A	21 Mar 07	1454	Cloudy	0.0%	0.0%	18.7%
Point B1	21 Mar 07	1508	Cloudy	0.0%	0.0%	18.5%
Point B2	21 Mar 07	1502	Cloudy	0.0%	0.0%	18.6%
Point C1	21 Mar 07	1511	Cloudy	0.0%	0.0%	18.5%
Point D	21 Mar 07	1517	Cloudy	0.0%	0.0%	18.5%
