**Contract No. : EP/SP/52/06**  
**Development of an EcoPark in Tuen Mun Area 38**

**ENVIRONMENTAL MONITORING AND AUDIT**

**MONTHLY EM&A REPORT for**

**MAY 2007**

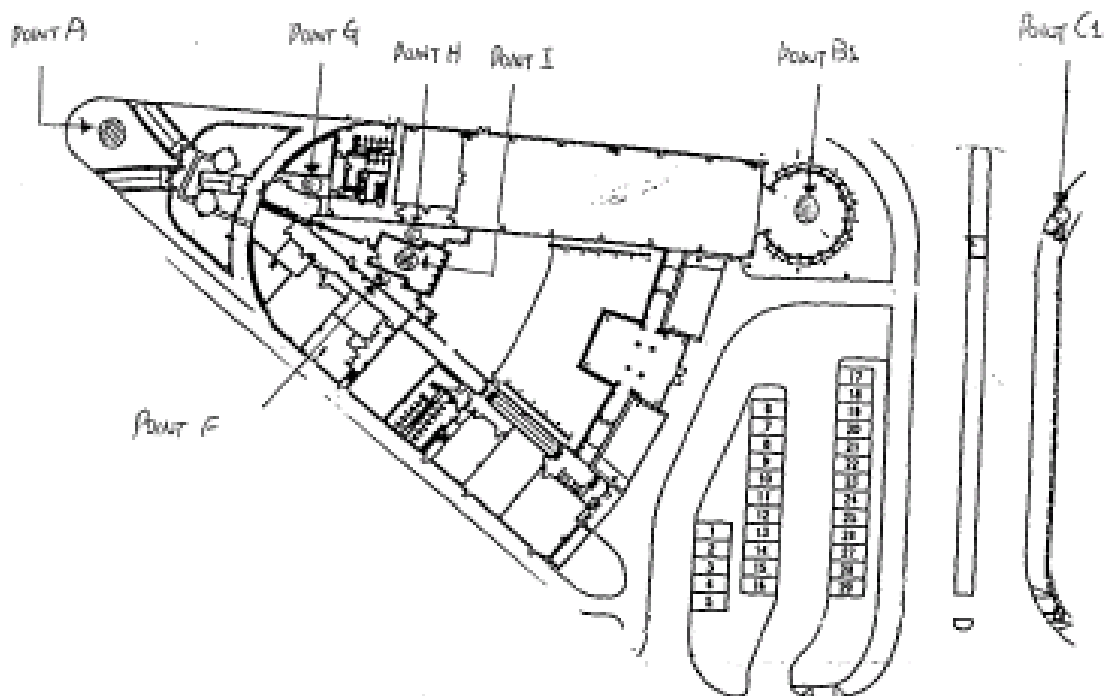
Site layout

Kaden Construction Limited		Job No. K0603		
		EPD Contract No. EP/SP/52/06		Development of EcoPark in Tuen Mun Area 38		
<b>Daily Air Monitoring</b>			<b>每日空氣監測記錄</b>			
Detector: 測試器	Model 型號: GEM 2000	Last calibration 上次檢測: 03 Apr. 07				
	S/N 編號: GM-08793	Next calibration 下次檢測: 02 Apr. 08				
Date of Monitor 監測日期: 2 May 2007			Performed by: Harry Lam			
Location 位置	Time 時間 (hrs)	Result 結果				
		CH <sub>4</sub> (%)	CO <sub>2</sub> (%)	O <sub>2</sub> (%)	Bal. Gas (%)	Baro. Pressure (Hg)
Point A	1455	0	0	18.2	81.7	29.79
Point B1 (Production Gallery)	1509	0	0	17.9	82.0	29.79
Point C1 (FMH049)	1511	0	0	17.8	82.1	29.79
Point F (E&M room)	1504	0	0	18.0	81.9	29.79
Point G (PS room)	1458	0	0	18.1	81.8	29.79
Point H (E&M room)	1501	0	0	18.0	81.9	29.79
Point I (E&M room)	1503	0	0	18.0	81.9	29.79

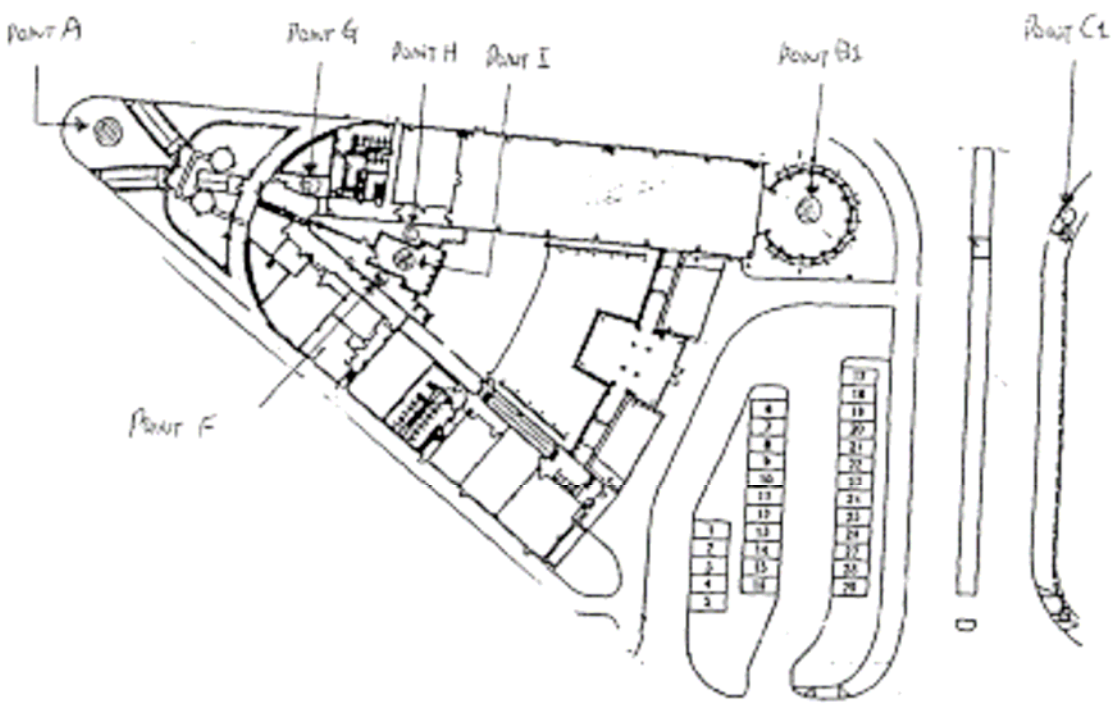
Site layout

Location 位置	Time 時間 (hrs)	Result 結果				
		CH <sub>4</sub> (%)	CO <sub>2</sub> (%)	O <sub>2</sub> (%)	Bal. Gas (%)	Baro. Pressure 氣壓 (mmHg)
Point A	<i>1521</i>	<i>0</i>	<i>0</i>	<i>20.1</i>	<i>79.8</i>	<i>1005</i>
Point B1 (Production Gallery)	<i>1543</i>	<i>0</i>	<i>0</i>	<i>20.2</i>	<i>79.8</i>	<i>1005</i>
Point C1 (FMH049)	<i>1547</i>	<i>0</i>	<i>0</i>	<i>20.2</i>	<i>79.8</i>	<i>1005</i>
Point F (E&M room)	<i>1531</i>	<i>0</i>	<i>0</i>	<i>20.1</i>	<i>79.8</i>	<i>1005</i>
Point G (FS room)	<i>1527</i>	<i>0</i>	<i>0</i>	<i>20.2</i>	<i>79.8</i>	<i>1005</i>
Point H (E&M room)	<i>1537</i>	<i>0</i>	<i>0</i>	<i>20.2</i>	<i>79.8</i>	<i>1005</i>
Point I (E&M room)	<i>1534</i>	<i>0</i>	<i>0</i>	<i>20.2</i>	<i>79.8</i>	<i>1005</i>

Landfill Gas Measurement by using ET's Instrument

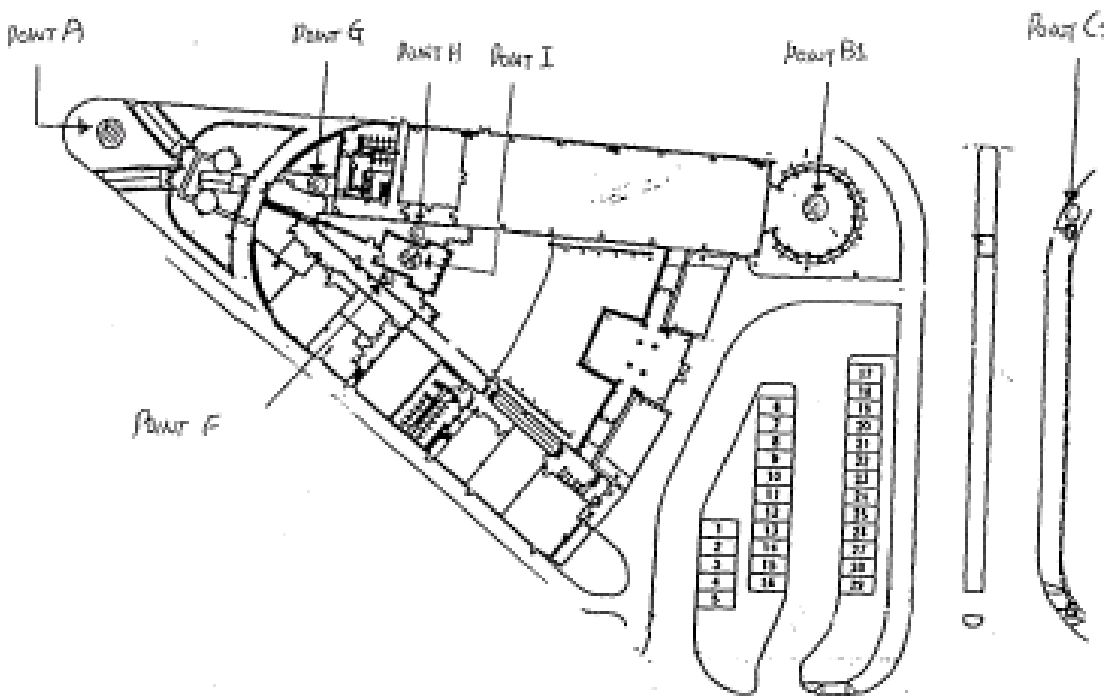
Site layout

Location 位置	Time 時間 (hrs)	Result 結果				
		CH <sub>4</sub> (%)	CO <sub>2</sub> (%)	O <sub>2</sub> (%)	Bal. Gas (%)	Baro. Pressure (°Hg)
Point A	1519	0	0	18.2	81.8	29.76
Point B1 (Production Gallery)	1542	0	0	17.5	82.4	29.76
Point C1 (FMH049)	1546	0	0	17.5	82.4	29.76
Point F (E&M room)	1529	0	0	17.6	82.3	29.76
Point G (FS room)	1526	0	0	17.8	82.1	29.76
Point H (E&M room)	1536	0	0	17.6	82.3	29.76
Point I (E&M room)	1533	0	0	17.6	82.4	29.76

Landfill Gas Measurement by using the Contractor's Instrument
