**Contract No. : EP/SP/52/06**  
**Development of an EcoPark in Tuen Mun Area 38**

**ENVIRONMENTAL MONITORING AND AUDIT**

**MONTHLY EM&A REPORT for**

**NOVEMBER 2006**

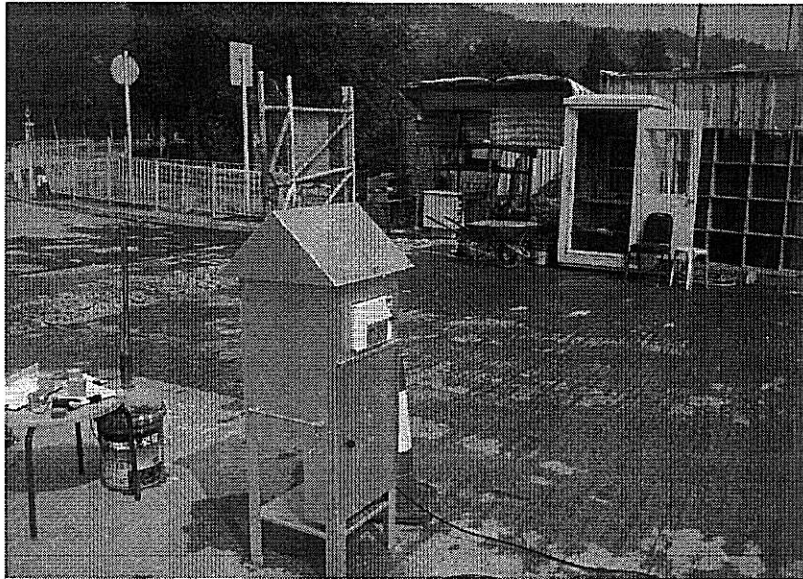
**Photos of High Volume Air Sampler**

APPENDIX 4 – LOCATION PLAN AND PHOTOS OF HIGH VOLUME AIR  
SAMPLER.....21
