Contract No. : EP/SP/52/06
Development of an EcoPark in Tuen Mun Area 38

ENVIRONMENTAL MONITORING AND AUDIT

MONTHLY EM&A REPORT for

OCTOBER 2006

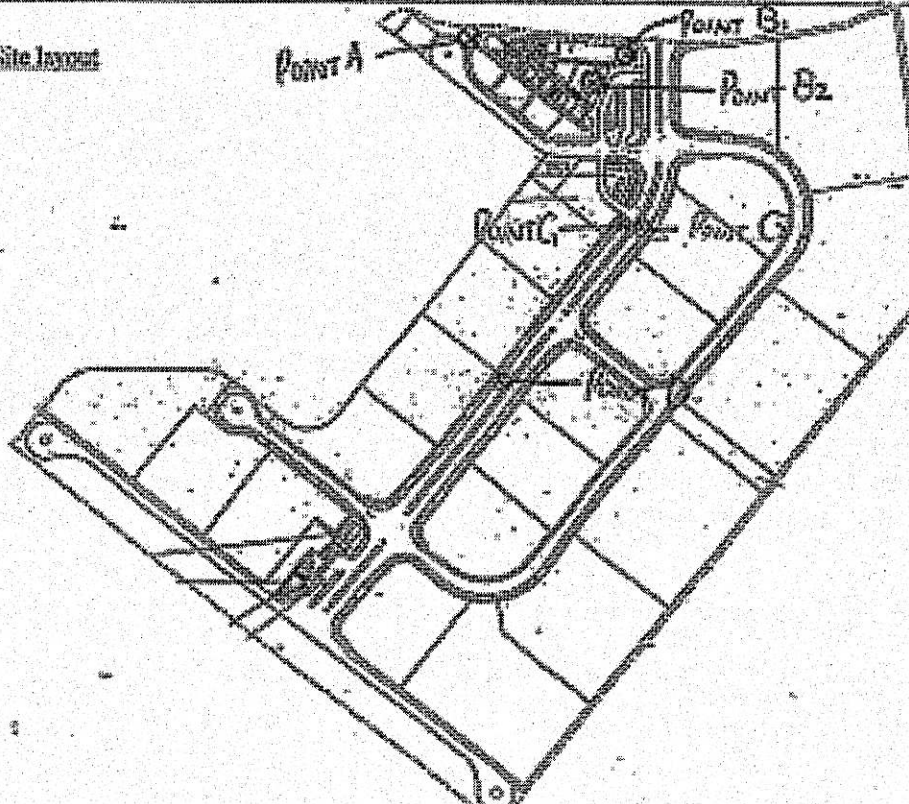
Site layout

Location 位置	Time 時間 (hrs)	Result 結果				
		CO ₂ (%)	CO (%)	O ₂ (%)	Rel. Gas (%)	Baro. Pressure (hPa)
Point A	10:25	0	0	19.8	80	30.06
Point B1	10:35	0	0	19.6	80.3	30.06
Point B2 (Rainwater retention tank)	10:30	0	0	19.6	80.1	30.06
Point C1 (FMH041)	10:40	0	0	19.5	80.5	30.06
Point C2 (FMH040)	10:43	0	0	19.4	80.6	30.06
Point D	10:50	0	0	19.3	80.7	30.06
Point C1 (FMH041)						
Point C2 (FMH040)
