Issue Date: October 2018

ECOPARK OPERATION

QUARTERLY ENVIRONMENTAL MONITORING & AUDIT REPORT (JULY – SEPTEMBER 2018)

ALLIED ENVIRONMENTAL CONSULTANTS LTD.

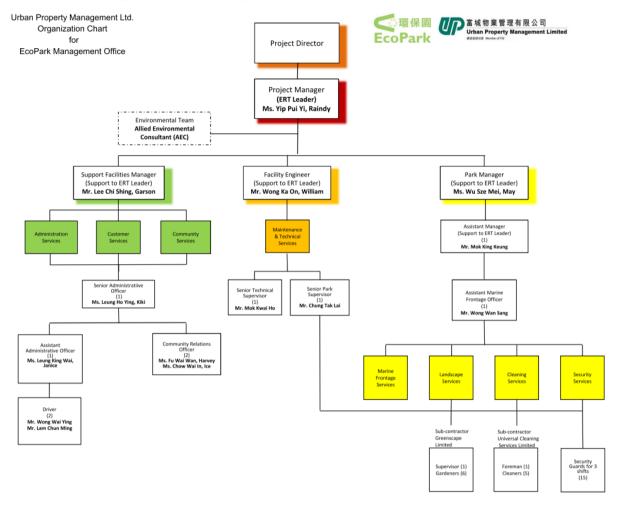
Figure 1-2 Organisation Chart of UPML

1.3.2 The organisational structure and lines of communication for the operation of EcoPark with respect to environmental management is given in *Figure 1-2* and *Figure 1-3* respectively.
